**Western Star  
Service Bulletin**

Use the guidelines in this bulletin to determine if a damaged electrical harness should be repaired or replaced.

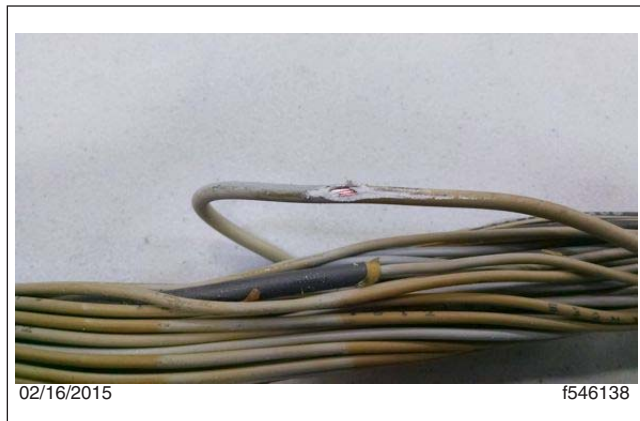
Wire Damage Quick Reference	
Description	Remedy
Kinked Wire	Repair
Melted Insulation, Major.	Replace
Melted Insulation, Minor	Repair
Worn or Missing Insulation. See <a href="#">Fig. 1</a> .	Repair
Discolored or Cracked Insulation, Major. See <a href="#">Fig. 2</a> .	Replace
Discolored or Cracked Insulation, Minor.	Repair
Datalink, Twisted Wire  NOTE: If only the terminals are damaged, the terminals can be replaced without replacing the twisted pair.	Replace
Corrosion in the Wire*	Repair
Corrosion in the Connector	Repair
Failed Terminal Pair Drag Test	Replace Terminal
Molded Cable†	Replace

**Fig. 1, Worn Insulation, Major**

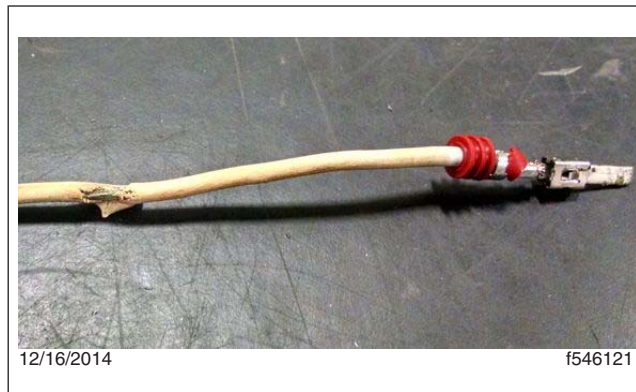
**Fig. 2, Insulation Discoloration, Major**

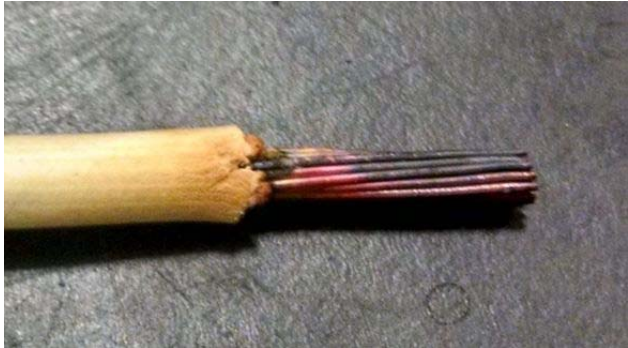
Identifying a Repairable Wire		
Condition	Description	Example
<b>Corroded Wire</b>	<p>Corroded wires can be repaired by cutting out the damaged section. The wire needs to be cut until only clean wire is found for repair. It may be necessary to add a jumper wire to create slack and avoid wire tension. Refer to the instructions in this bulletin to install a jumper wire.</p> <p>The example shows a small amount of corrosion at the end of the wire.</p>

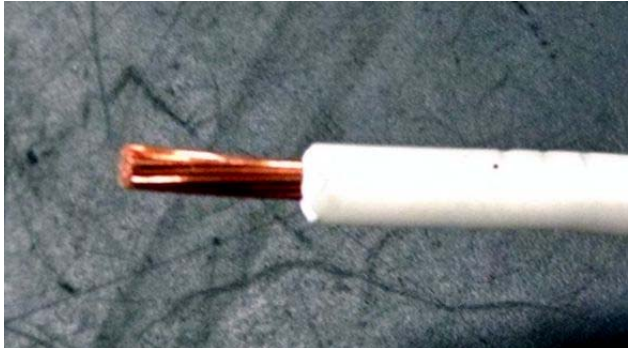
<p>12/16/2014 <span style="float: right;">f546117</span></p>
<b>Cut Wire (clean) or Worn Insulation</b>	<p>If the wire shows no sign of corrosion, the wire can be repaired with a splice kit.</p>
