SUBJECT: **EPA07 and EPA10 DD Platform Engines With Low Oil Pressure Codes**

**ISSUE**

EPA07 and early EPA10 DD Platform engines may experience low oil pressure codes not related to low oil level or oil dilution.

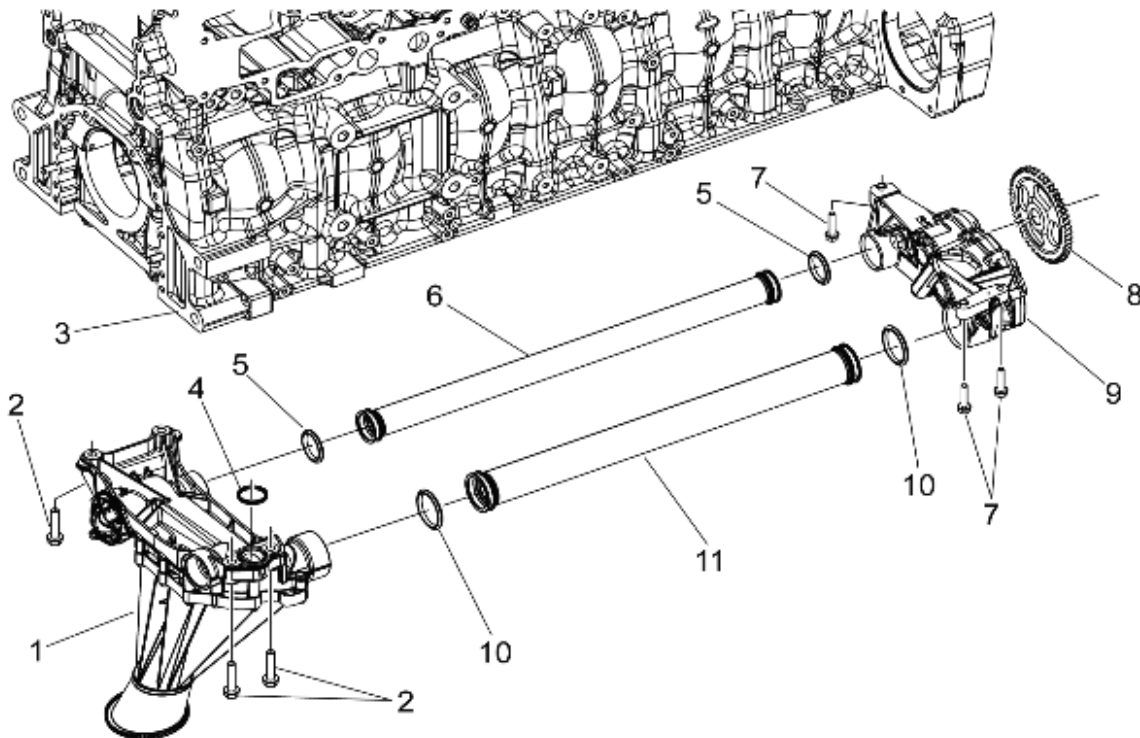
**Figure 1 – O-ring Location**

There are five O-rings related to the oil pick-up tube assembly that may become brittle and allow air to enter the engine oil system. This failure mode is experienced only at high mileages – generally, 400,000 miles and greater. See Figure 1. The O-rings in question are item numbers 4, 5 (two locations), and 10 (two locations).

Improved pickup tube seals (item numbers 5 and 10) became effective with engine s/n (last six digits) 170300 built on November 20, 2012. Not all units before the changepoint will have this issue.

Improved oil suction manifold seal (item number 4) became effective with engine s/n (last six digits) 206879 built on August 8, 2013. Not all units before the changepoint will have this issue.

Once low oil pressure codes are verified, the O-rings may need to be replaced. In extreme cases, the rod bearings may need to be inspected and replaced.

In rare cases, the oil suction manifold may also need to be replaced if an acceptable oil pressure is not achieved after the initial O-rings are replaced.

Verify low oil pressure complaint with a manual gauge or using DiagnosticLink™. If verified, check the O-rings for item numbers 4, 5 (two locations), and 10 (two locations). Remove the oil pan and inspect for signs of bearing debris. If no debris is found, reinstall the oil pan. If bearing debris is found, remove and inspect the rod bearings. If rod bearings show severe distress, replace the crankshaft. See Figure 2, Rod Bearing Inspection. In extreme cases only, if replacing O-rings for item numbers 4, 5 (two locations), and 10 (two locations), do not give the desired pressure of greater than 11 psi (DD13, DD15TC, DD16) or 10 psi (DD15AT) at idle and operating temperature, the oil suction manifold should be replaced.

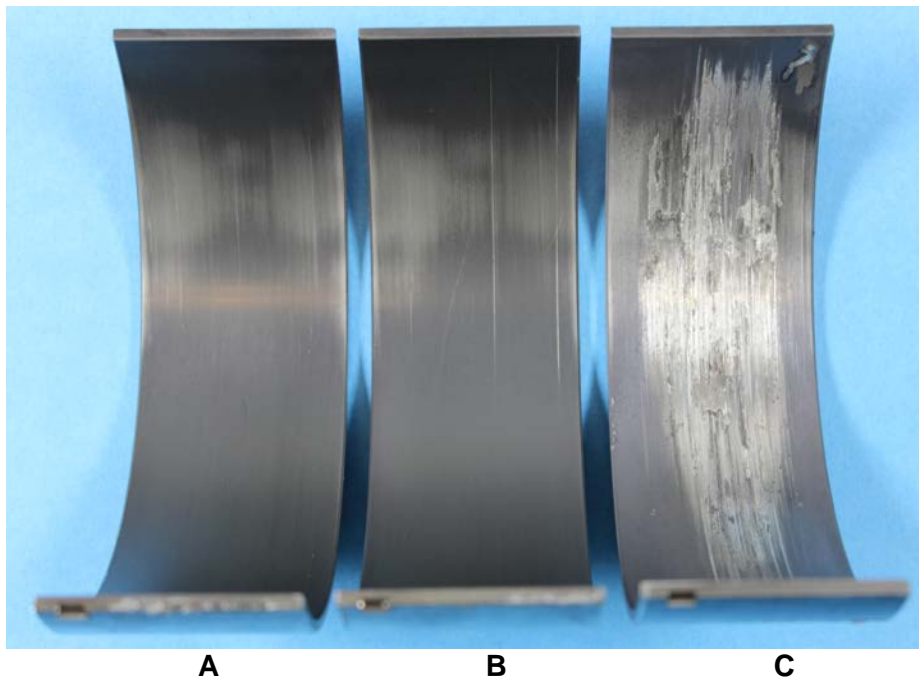
**Figure 2 – Rod Bearing**

Bearing A – No signs of distress, normal wear for high mileage bearing.

Bearing B – Small scratches on rod bearing surface, but typical for high mileage bearing.

Bearing C – Bearing surface shows heavy signs of damage. Replace crankshaft, main bearings, and rod bearings.

**A rod bearing inspection is only required if signs of metal debris are present in the oil pan.**
