No.: 15 TS-5Rev
February 3, 2015

SUBJECT: **GHG14 DD Platform DEF Pump Leaks and Code 4374/FMI 0 Under Pressurized DEF System**

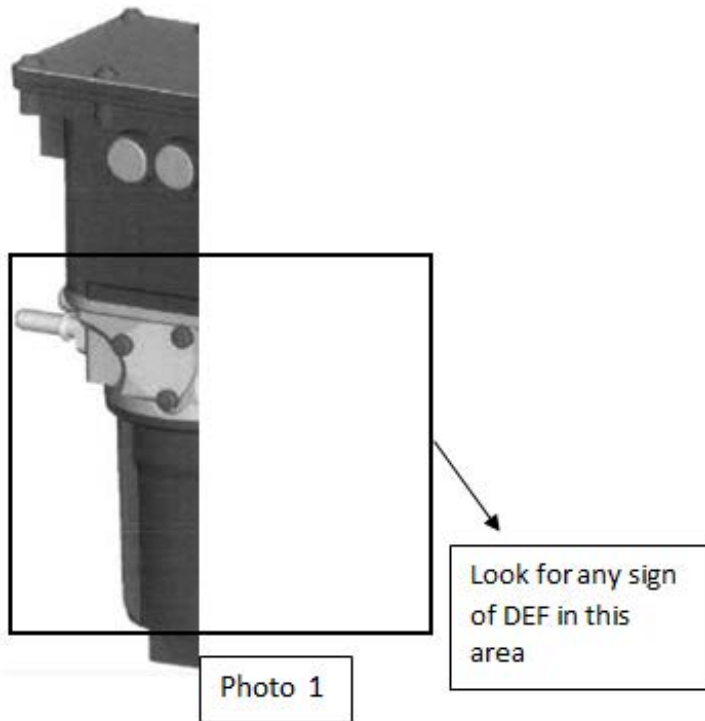
Detroit has identified DEF pump leaks from the filter housing and visible on the plastic housing. The frost protection membrane tears, causing DEF to leak from the filter housing. The fault code associated with this failure is SPN 4374/FMI 0 – DEF Pump Speed High.

Inspect the DEF pump housing for signs of DEF leaks in the area defined by the photo 1.
Remove the frost protection membrane and turn it inside out to identify tears similar to photo 2.
Replace the membrane as necessary using the kit part number below:

Filter Insert - DDE A0001420789

DO NOT replace the DEF pump.
