Document ID: IK1200376
Revision: 3
Created: 5/20/2009
Last Modified: 8/27/2015
Author: Randy Geweniger

Title: Stumble or misfire on acceleration and setting cam codes on I6 engines from 1995 to present.*

Applies To: DT466 DT530 DT570 Maxxforce Engines

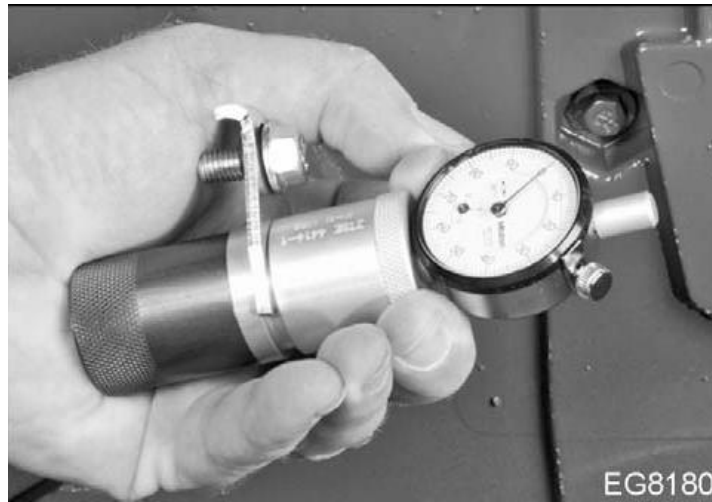
1. These cam codes can be set due to camshaft end play out of spec and may not even set a code at all but the truck is experiencing a surge, stumble, or misfire under a load during acceleration.
2. The camshaft end play will need to be checked, to do this you will need tool ZTSE4414 on pre EGR engines.

The front cover will have to be removed and the cam gear will have to be replaced.

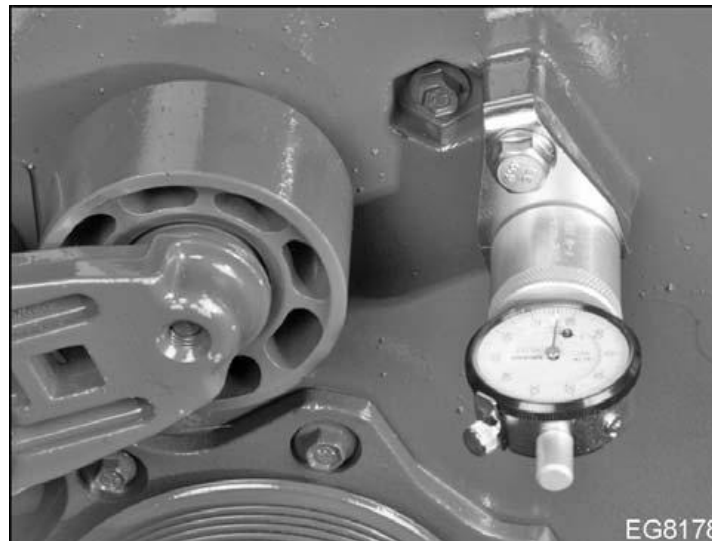
3. Remove the cam sensor and install the camshaft end play tool. Once the tool is installed rotate clockwise by hand 14 times and stop to zero out the tool. Next rotate the engine by hand 14 times counter clockwise and record the reading. The end play should be 0.005-0.013in, if it is higher than this the cam gear has walked off the camshaft.
