**Title:** Injection Pressure Regulator (IPR) Pigtail

**Applies To:** MaxxForce 07-09 and 2010 DT, 9, & 10 engine builds and later (ESN 3000000 to 3999999)

## 2010 and later Maxxforce DT, 9 and 10 Engines

### IPR KIT 1889325c94

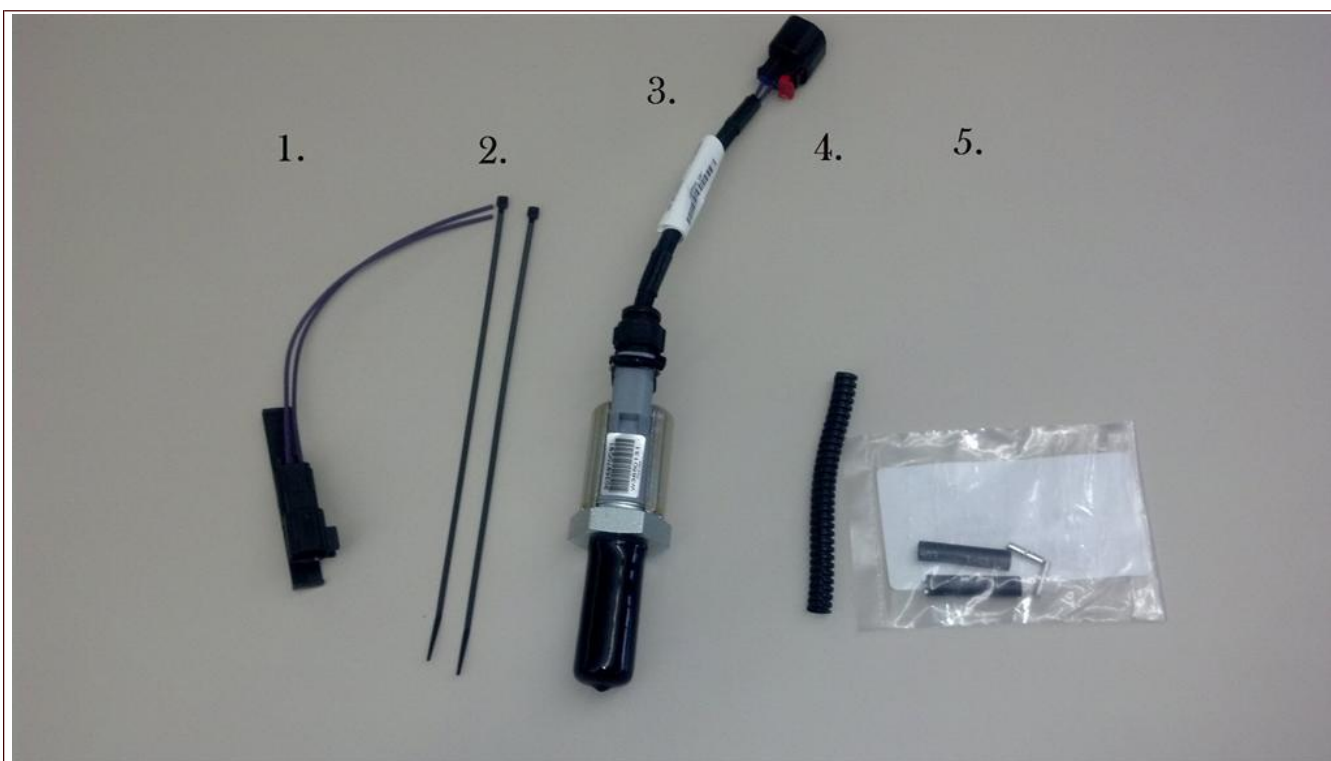
**Figure 2: IPR With new connector**

- A new IPR Kit has been released. The new style has a remote mounted connection 7 inches from the IPR valve (figure 2).
- **The connection at the IPR valve is no longer serviceable and disassembly should not be attempted (figure 2).**
- The kit includes a new IPR valve, IPR pigtail, zipties, butt connectors, convolute, and directions for installing the new IPR (figure 3).
- The IPR Solenoid needs to be clocked properly, refer to the included instruction sheet for proper installation.
- The new style IPR requires the use the new tool 12-800-01(see figure 4 below)
- Tool instructions are available on the Service Tool Resource Center (TL2900008).

1. Not servicable: Do not attempt to disconnect
2. Remote mounted connector.

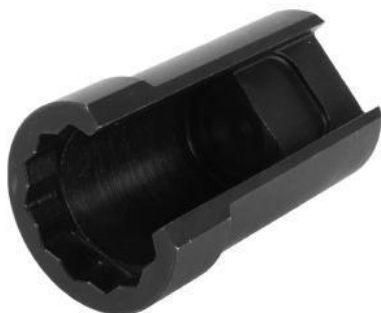
**Tool Number: 12-800-01**

**Figure 4: Glued IPR valve requires Tool # 12-800-01**

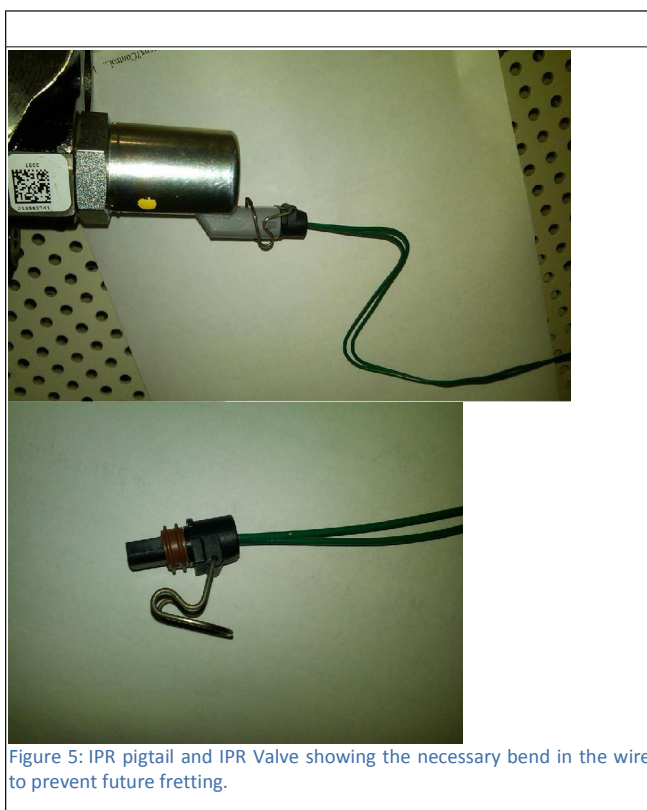
- IPR pin fretting increases resistance at IPR connection.

Figure 5: IPR pigtail and IPR Valve showing the necessary bend in the wire to prevent future fretting.

- Replace IPR valve and/or pigtail; leave generous length of wire to allow movement. The IPR pigtail service part must have a 90mm wire tail between the IPR connector and the wiring harness. See Figure 5 below.
    - Use a generous amount of Dielectric Grease.
- TEST alteration

**IPR Pigtail Part Number: 2501107C1\***

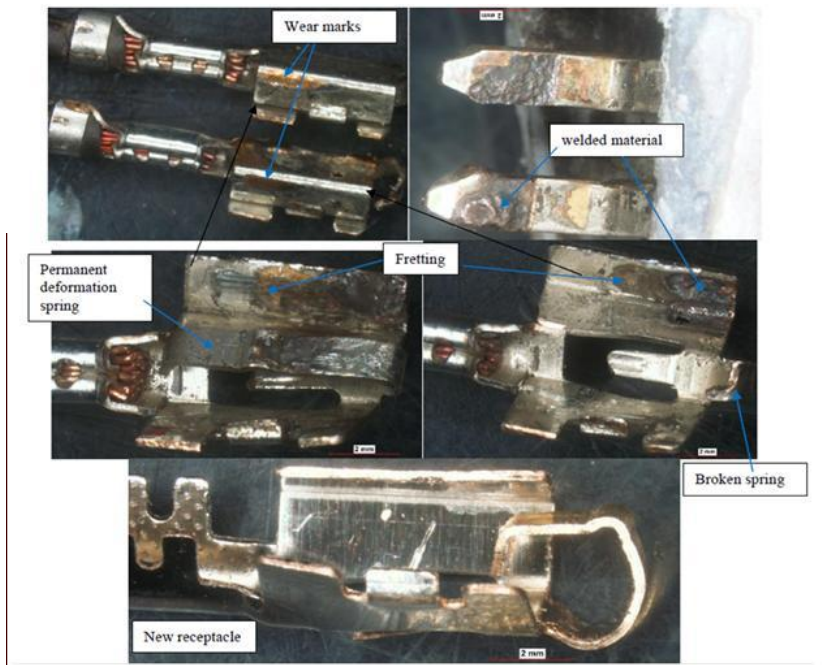
Figure 6: Examples of damage to the IPR valve pins and connector
