**Document ID:** IK1200753

**Title:** Hydrocarbon Injector & Housing Cleaning Procedure (AFI Plugging)

**Applies To:** EPA 2010 MaxxForce DT, 9, 10

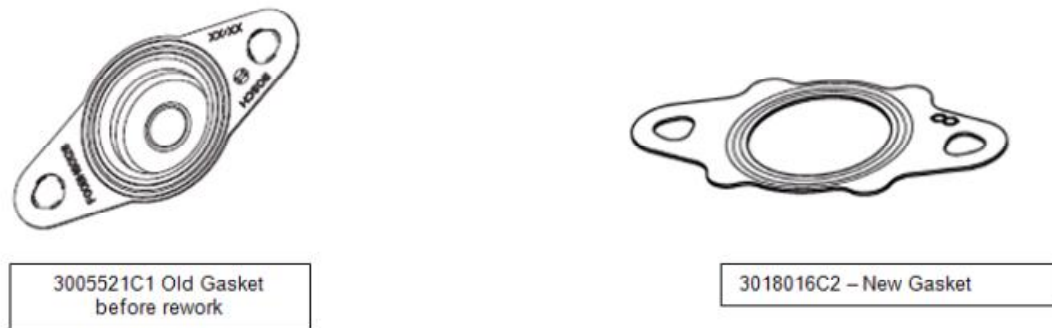
**Figure 1 - Gasket Changes**

The old gasket (p/n **3005521C1**) has been reworked and replaced with p/n **3018016C2**. The new style gasket will have the raised center portion of the gasket removed (Figure 1).

3. Install plastic plug on fuel and coolant openings of AFI
4. Perform visual inspection of the AFI. Visual Checks:
  - a. Correct AFI gasket is installed. (See figure 1)

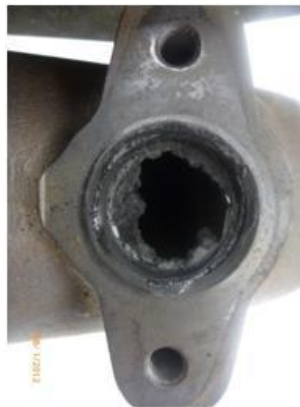
A plugged HC injector port will result in frequent aftertreatment regenerations (regens) or low temperatures during On Board Filter Cleanliness Test (OBFCT). If the AFI port is plugged, use this procedure and Navistar's Engine Diagnostic Manual (Found on the **Service Portal>Publications>Master Service Information**) for additional reference.

**Figure 2 – Partially plugged AFI port**

- b. AFI body and fittings free of cracks and other damage.
  - c. AFI tip free of cracks and other damage.
5. Use ZTSE4301 (Brass Brush) to clean any carbon buildup that may be present at the tip of the AFI.
  6. If carbon buildup is present: Carefully remove carbon from the HCI / AFI port on the exhaust back pressure valve housing with a chisel or other appropriate tool. Remove debris with a shop vac.

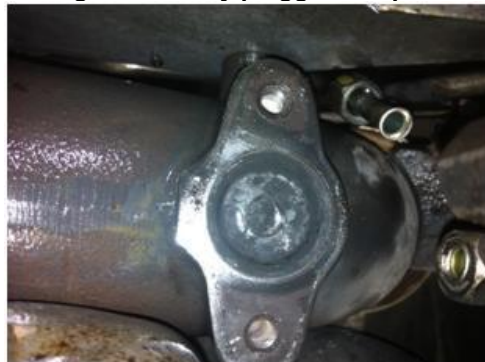
Standard operating cleaning procedure of the exhaust brake housing and HC Injector, for proper Aftertreatment system operation. **DO NOT** remove the HC injector unless a SPN 3556 fault is present.

**Figure 3 – Fully plugged AFI port**

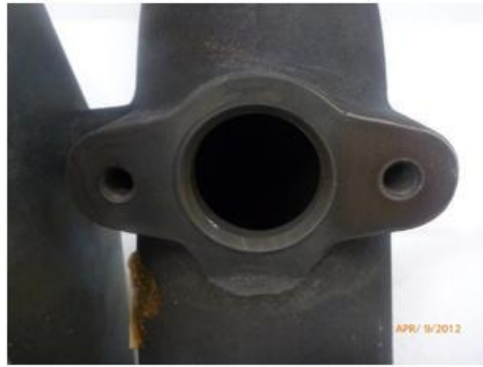
**Figure 4 – Clear AFI port after cleaning**
