STAR CENTER NEWS

March/April Announcements

March/April 2015

No. 87

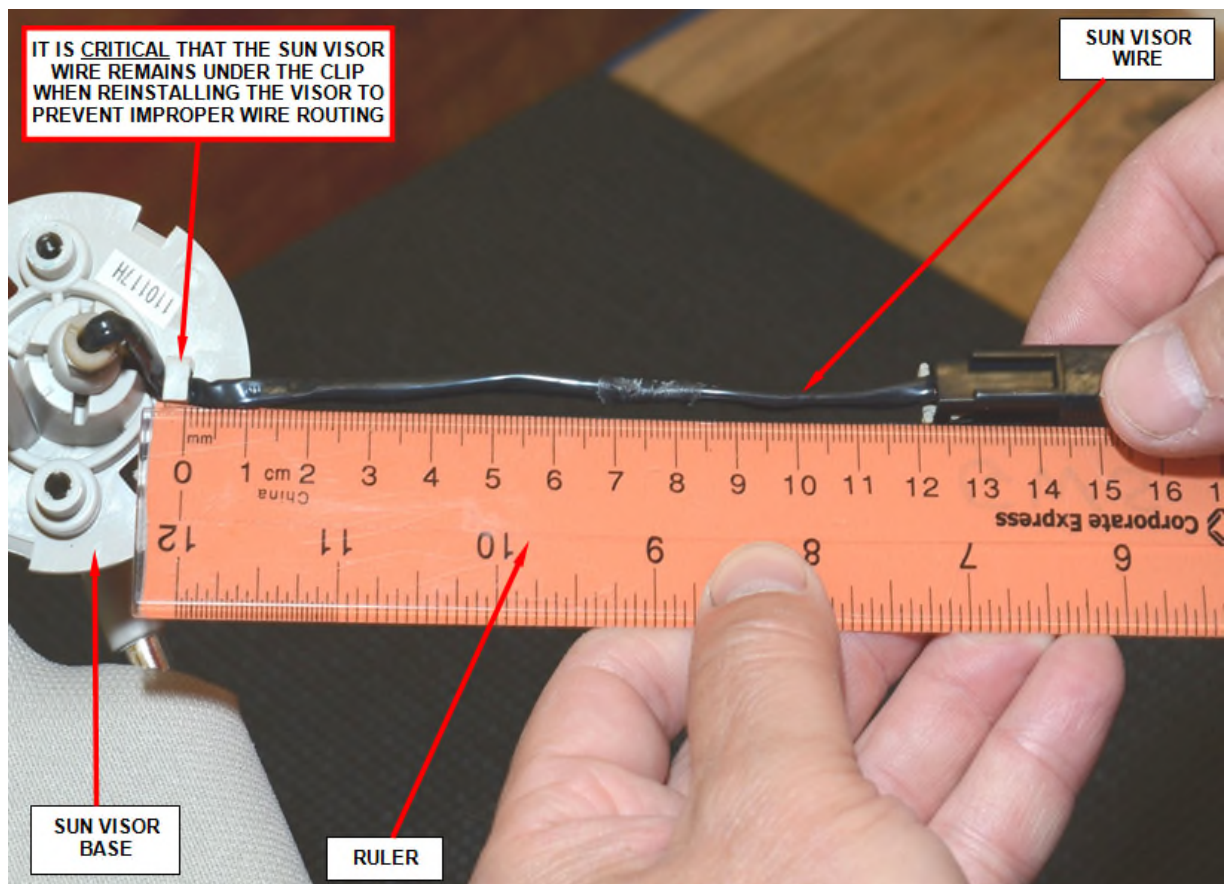
It is critical that the sun visor wire remains under the clip when reinstalling the visor to prevent improper wire routing.

Figure 1 – Wire Must Be Clipped Before Installing the Sun Visor

There may have been some confusion on how to route the sun visor wires by a very small group of dealership technicians. It is very important to follow the Dealer Service Instruction provided for this recall.

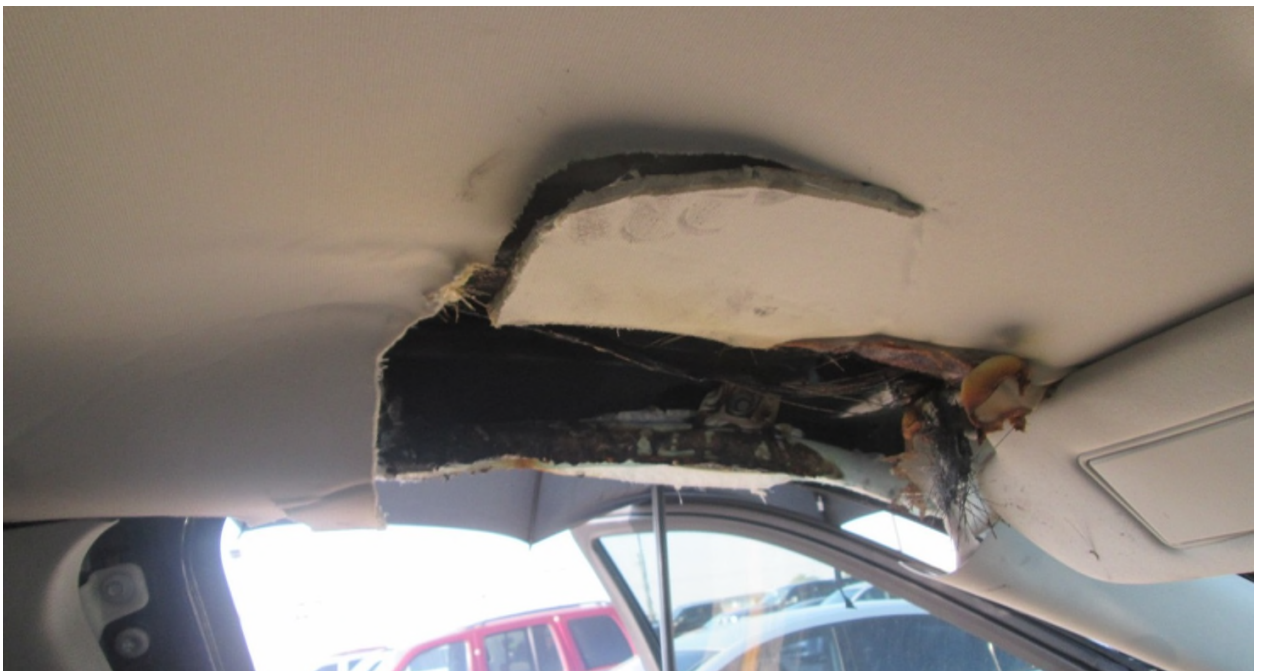
Below are some pictures of what could result if this recall is not performed correctly. The results shown below will not enhance the customer’s perception of your dealership and or FCA US LLC.

Figure 2 – Result of Improperly Performed Recall

We ask that you make every effort to convey to all your service technicians the importance of performing this recall properly and to follow the instructions provided on TechCONNECT.

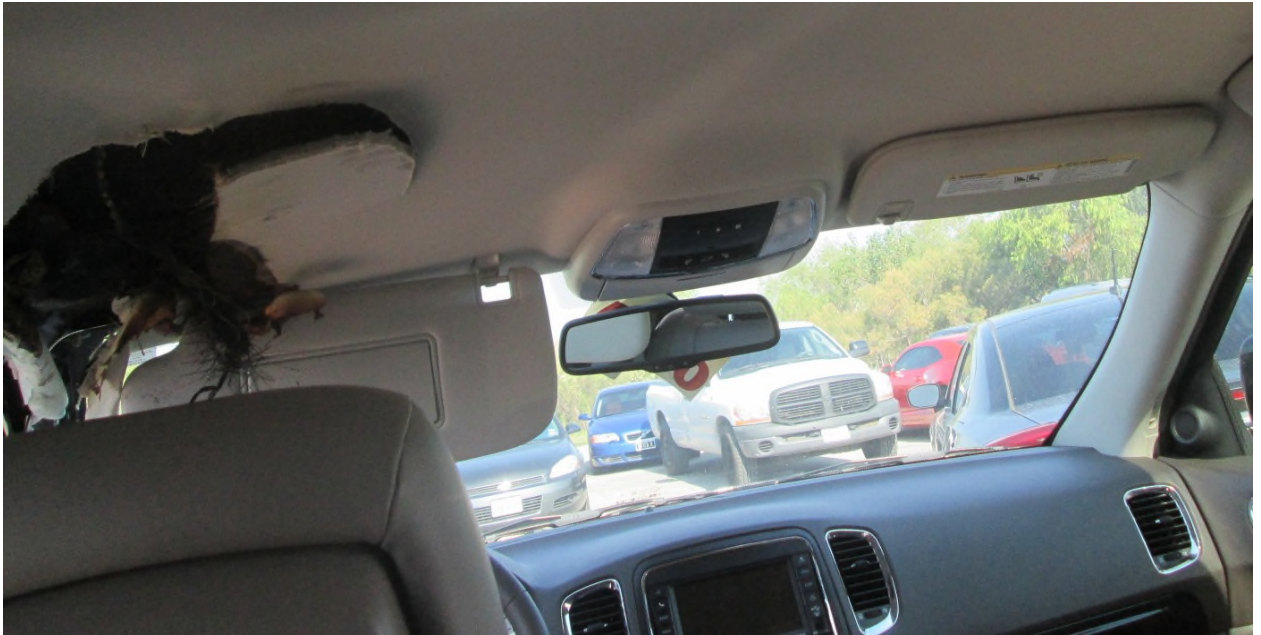
Figure 3 - Result of Improperly Performed Recall

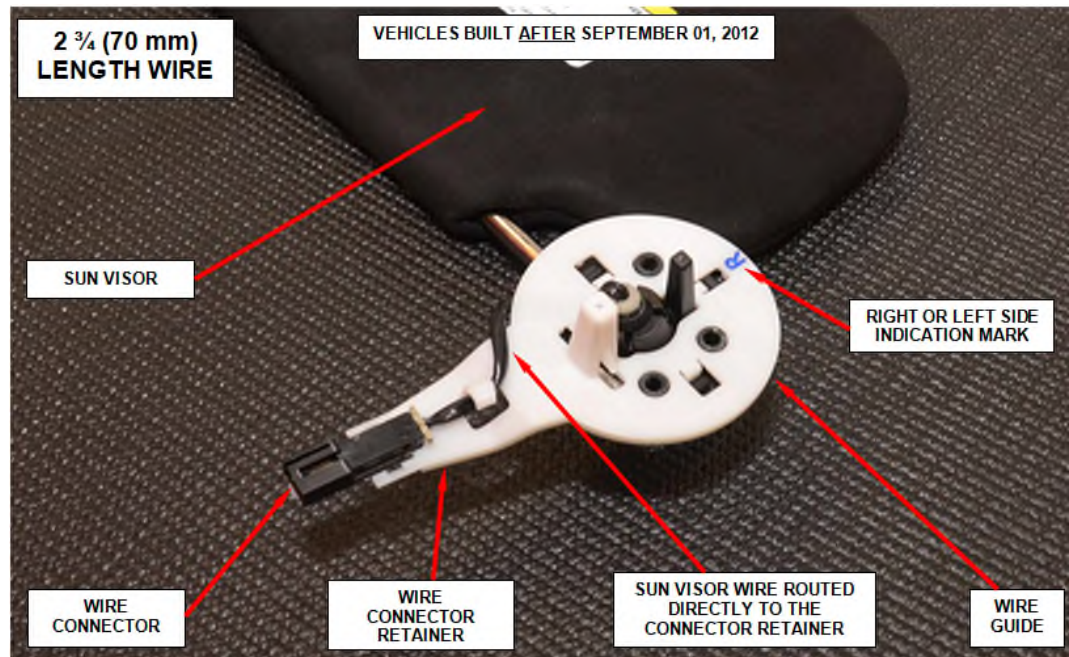
Page 10 of the recall shows the two different wire length configurations that a technician may encounter during the repair. It is very important to determine if the vehicle has the short sun visor wiring (2 ¾ in.) or the long sun visor wiring (4 ¾ in.) and to route the sun visor wiring as shown in the service instructions (see Figure 13 and 14 of the recall and/or attached photos).

Figure 13 - Sun Visor Wire Routing (2 ¾ Inch / 70 mm Length Wire)
 (Parts removed from vehicle for photographic purposes only)

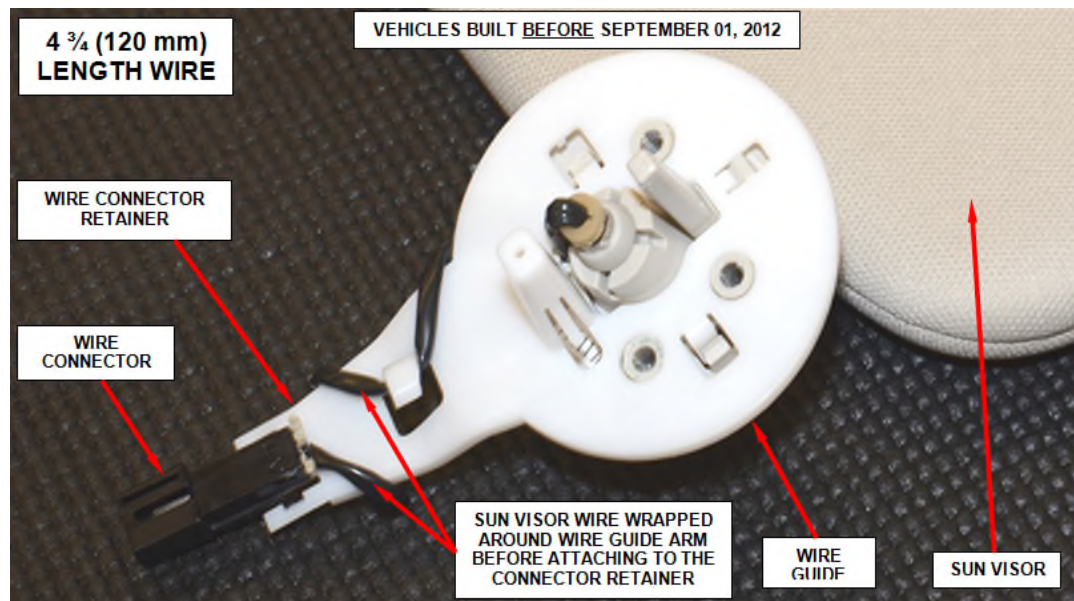
Figure 14 – Sun Visor Wire Routing (4 ¾ Inch / 120 mm Length Wire)
 (Parts removed from vehicle for photographic purposes only)

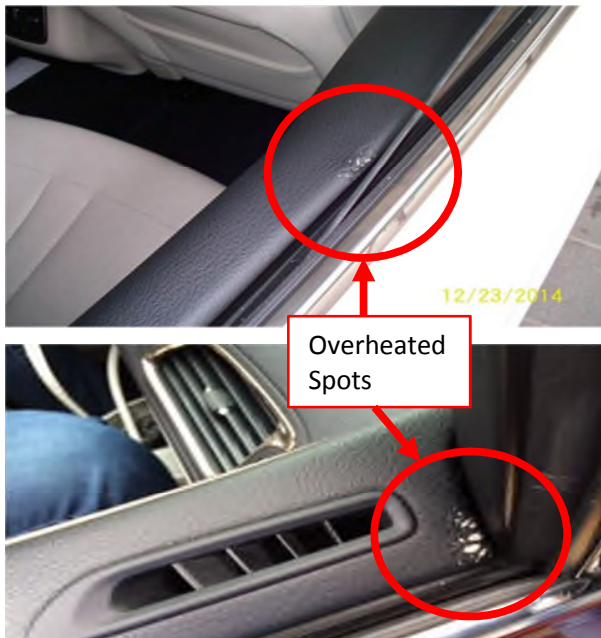
Figs. 1 & 2

Warranty claims have been emerging for damage to door trim on UF, KL and DS. The damage is seen as heated spots in the PVC vinyl (Figs. 1 & 2) and is typically located at the top edge of the bolster. The damage is most likely caused by heat guns or high-intensity lights used when repairing paint on the door or neighboring pillar. Such damage can also occur using these tools to install window tinting.

When such repairs are performed, proper care must be taken to protect the door bolsters by applying heavy duty aluminum foil around top edge or by completely removing the door trim panels.

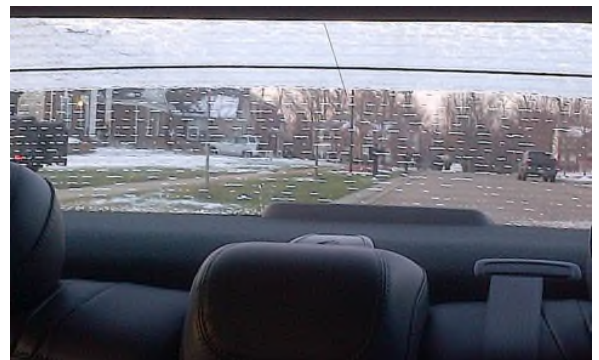
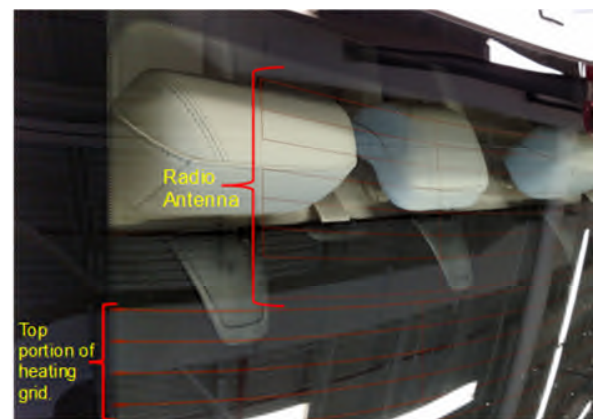
By design, the upper 12 inches of the backlite does not defrost on 2015 UF vehicles built prior to December 15, 2014. For vehicles built after December 15, 2014, the top backlite dead zone was reduced to 9 inches, which subsequently increased the size of the defrost pattern.

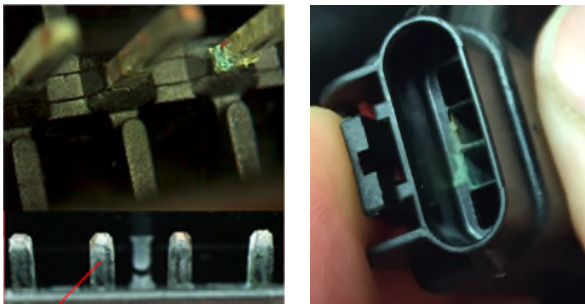
Figs. 1 and 2

When diagnosing 15 5.7L-equipped DS trucks with a P2008 - Short Runner Valve Control Circuit fault, make sure to check for evidence of moisture intrusion, including the presence of corrosion on the connector terminals in the SRV connector. Make sure to check both the SRV assembly and harness side-connectors. See accompanying pictures (Fig. 1 and 2) for examples of terminal corrosion.

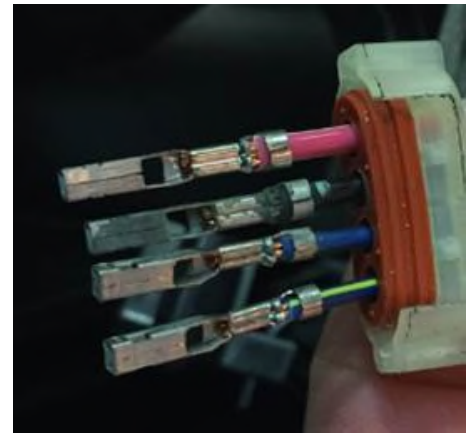
Fig.3

Disassembly of the harness-side connector may be necessary to observe any corrosion present on the terminal (Fig. 3).
