NUMBER: 23-010-15

Removal Of Challenger SRT Hellcat Front Air Dam Shipping Covers

Dodge Challenger

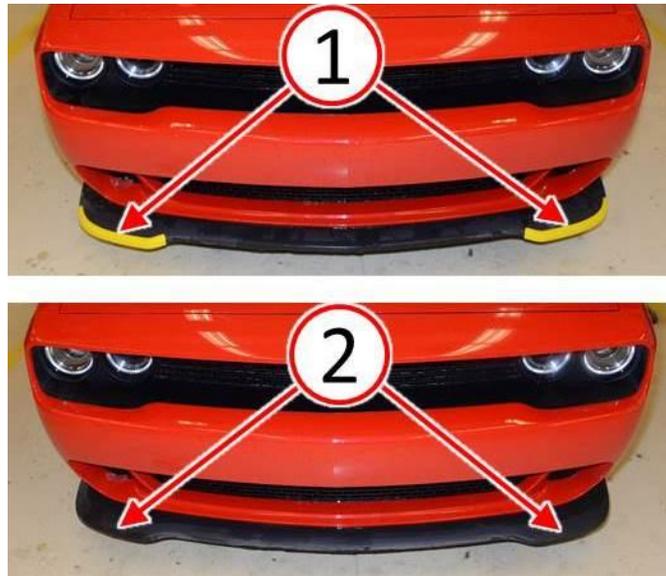
Fig. 1 Inspect Front Air Dam For Shipping Covers

Bright yellow shipping covers (1) have been added during vehicle production to prevent/lessen damage to the front fascia air dam during vehicle transport (Fig. 1).

If the bright yellow shipping covers are not installed on the front fascia air dam (2) (Fig. 1), this bulletin does not apply. No action is required.

1 - Bright Yellow Shipping Covers

2 - No Shipping Covers

If the customer describes the symptom/condition listed above or if the technician finds the shipping covers installed on the vehicle, perform the Repair Procedure.

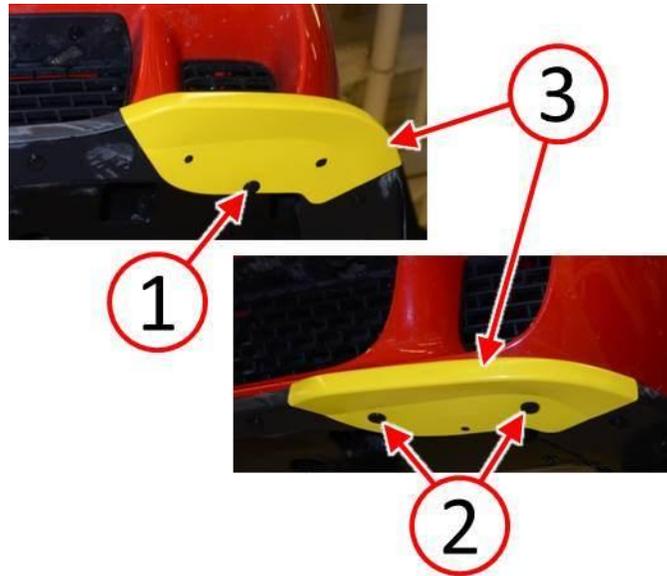
Fig. 2 Remove Front Air Dam Shipping Covers

1. Raise and support the vehicle. Refer to the detailed service procedures available in DealerCONNECT> TechCONNECT under: Service Info> 04 - Vehicle Quick Reference> Hoisting> Standard Procedure.
2. Shipping covers (3) may have one (1) or two (2) push pins retaining each cover, depending on installation (Fig. 2).

- 1 - One Push Pin
- 2 - Two Push Pins
- 3 - Shipping Cover

NOTE: If the shipping cover (3) is retained by one (1) push pin, the push pin may be discarded and does not require replacement (Fig. 2).

3. If the shipping cover (3) is retained by one (1) push pin as shown in (Fig. 2):
 - a. Remove and discard the push pin (1) and the shipping cover (3) from the right and left sides of the front air dam (Fig. 2). Repair process is complete, proceed to [Step #5](#).

NOTE: If the shipping cover (3) is retained by two (2) push pins, the push pins must be replaced with NEW push pins after removal of the shipping cover (Fig. 2).

4. If the shipping cover (3) is retained by two (2) push pins as shown in (Fig. 2):
 - a. Remove and discard both push pins (2) and shipping cover (3) from the right and left sides of the front air dam (Fig. 2).
 - b. Install NEW push pins into the four holes from which the shipping cover push pins were removed. Repair process is complete, proceed to [Step #5](#).
5. Lower the vehicle.
