NUMBER: 08-032-15

GROUP: Electrical

RE9 Radio Software Enhancements

This bulletin involves updating the radio and navigation software, if required.

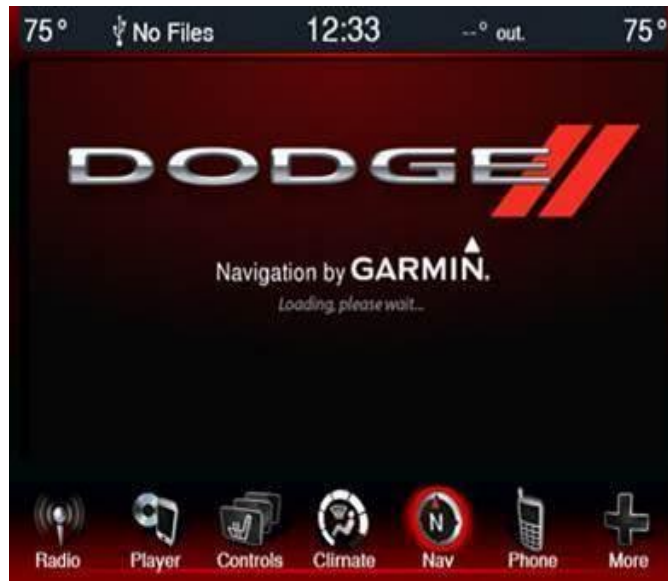
Fig. 1 System Loading Screen

1. Start the vehicle, turn the radio ON and allow it to power up.
2. Press the navigation screen button and attempt to access the navigation main menu screen.
3. Is the radio stuck on the “Loading Please Wait” screen? See (Fig. 1)
 - a. Yes <<< The radio will have to be replaced. Replace the radio using current electronic exchange center stock following normal warranty repair procedures. Refer to published service information in Tech Connect Section 08 - Electrical/8E - Electronic Control Modules/MODULE, Telematics Gateway/Removal. No further action is required, the bulletin is now complete. The replacement radio will contain the latest software update. Please use LOP 18-60-02-ES to close out the RRT portion of this bulletin.
 - b. No <<< Proceed to [Step #4](#) and perform the software update.

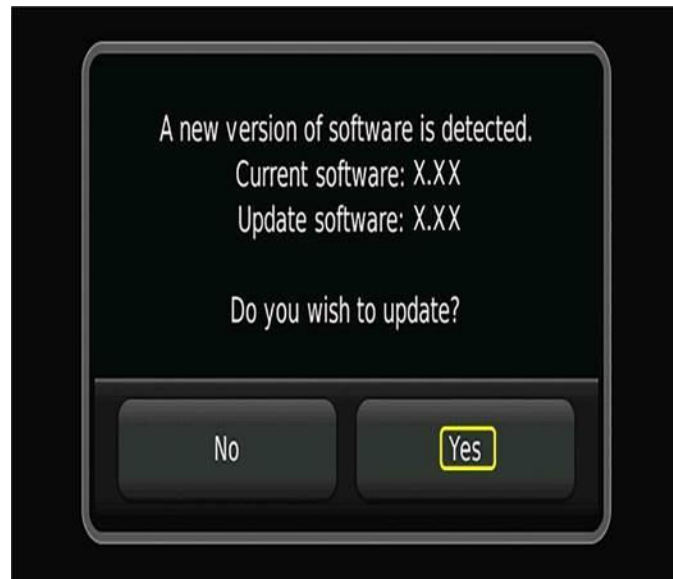
Fig. 9 Garmin Software Needs Updating

24. Which screen does the radio currently display?
 - a. (Fig. 8) <<< The radio has the latest Garmin software installed. Press OK and proceed to [Step #28](#).
 - b. (Fig. 9) <<< Press Yes to continue and proceed with the Garmin software update.
25. The first step in the update is “system recover”. There will be a pop up that indicates this step along with a progress bar. This will only take a few minutes.
26. This next screen will be displayed when the update is being down loaded, see ([Fig. 10](#))
