This Service Information bulletin and attachment supersedes SI B11 10 12 dated **January 2013**.

N20 Engine: Repeated Juddering or Surging While Accelerating

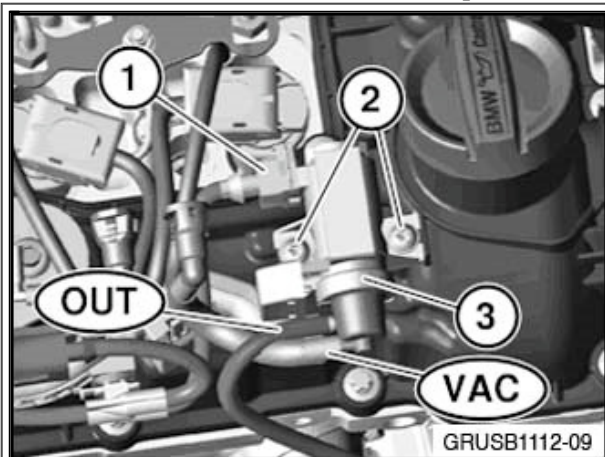
1. Remove the engine acoustic cover as per Repair Instruction 11 12 090, "Removing and installing/renewing acoustic cover (N20)."
2. Locate the EPDW located near the engine oil fill cap.

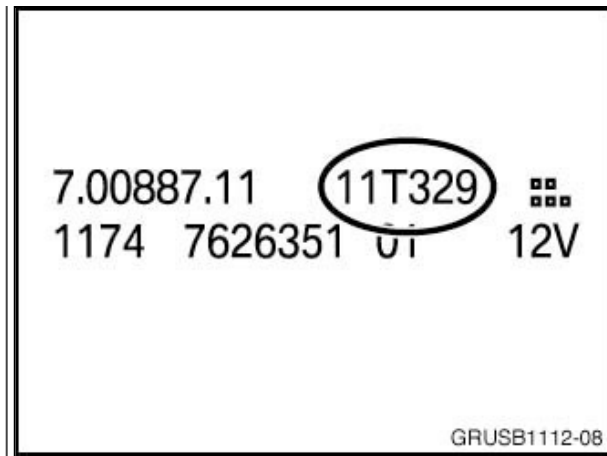
3. On the side the EPDW, there is a series of numbers printed.

The date code located on the side of the EPDW needs to be 12T158 or greater.

If the date code is 12T157 or lower, the EPDW will need to be replaced.

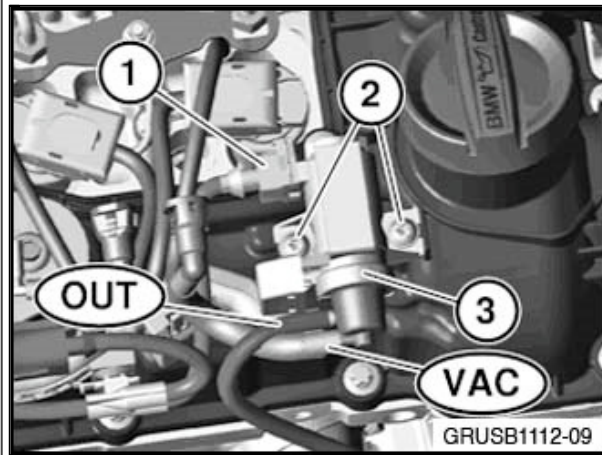
The EPDW (electropneumatic pressure convertor) for the turbocharger wastegate valve is binding internally.

4. Remove the electrical connector (1).
5. Remove the screws (2).
6. Remove vacuum lines marked "OUT" and "VAC."
7. Remove EPDW.
8. Install the new EPDW, connectors and vacuum lines. Install and torque the attaching screws to 3 Nm (2).
