This Service Information bulletin and attachment supersedes SI B11 16 14 **dated January 2015.**

**N63 Engine: Check the Timing Chain**

This bulletin outlines the procedure for checking the engine timing chains for wear, and **should be completed in conjunction with [SI B11 06 14](#)**, “N63 Customer Care Package.”

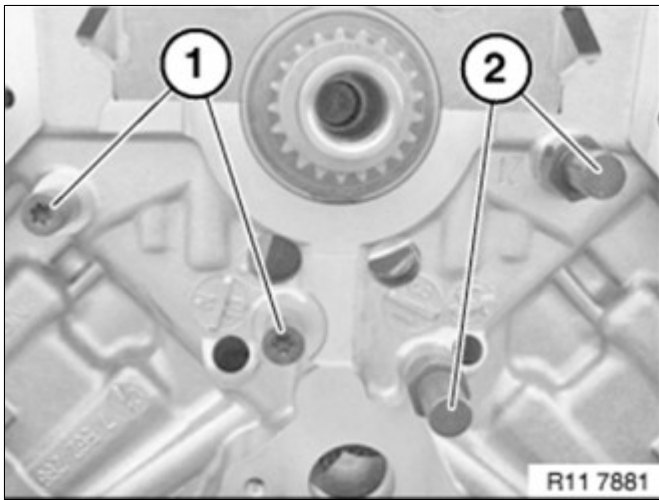
**Important Note:**

**NEW** The current ISTA repair manual RA11 31 052 “Replacing both timing chains \ PREMIUM” instructs to release tension on four bearing bolts (indicated as #1 for cylinders 5 to 8; and #2 for cylinders 1 to 4) on the engine block.

**NEW IT IS NOT NECESSARY TO DO THIS.**

**NEW DO NOT** release these bolts, because the bearing bolts are micro-encapsulated and they would have to be replaced if loosened up. The repair instructions will be updated soon.

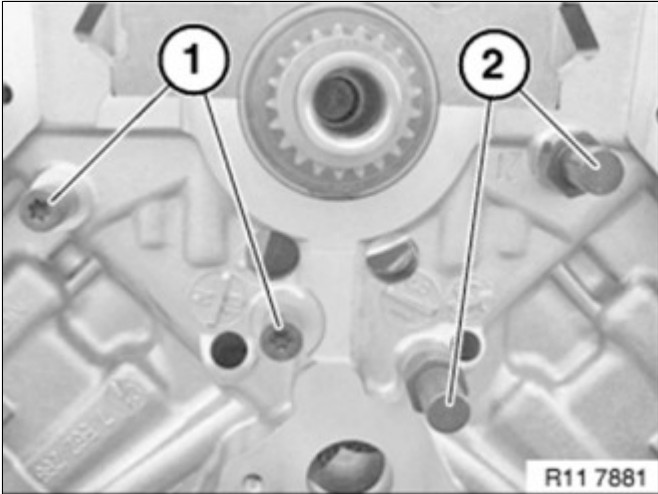
<p><b>Important Note:</b></p> <p><b>NEW</b> The current ISTA repair manual RA11 31 052 “Replacing both timing chains \ PREMIUM” instructs to release tension on four bearing bolts (indicated as #1 for cylinders 5 to 8; and #2 for cylinders 1 to 4) on the engine block.</p> <p><b>NEW IT IS NOT NECESSARY TO DO THIS.</b></p> <p><b>NEW DO NOT</b> release these bolts, because the bearing bolts are micro-encapsulated and they would have to be replaced if loosened up. The repair instructions will be updated soon.</p>
---	---
