Reduced Heat After Cooling System Repairs

F30 (3 Series Sedan)

With the N55 engine and option 0337 (M Sport Package)

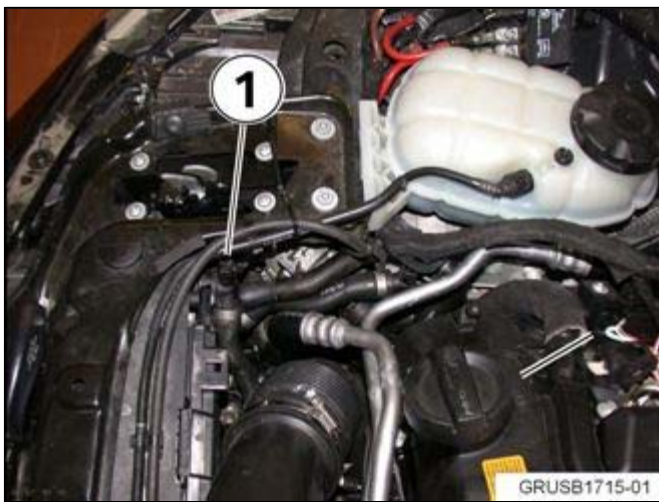
There are three hoses in the engine oil cooling system at the right side of the radiator (1).

(Note: The harness for the auxiliary fan has been removed for clarity.)

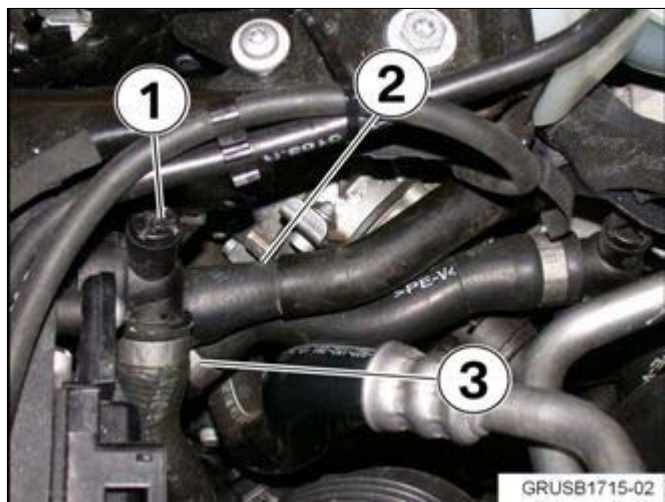
The top hose with the bleed screw (1) is attached to the cooler for the engine oil, and connects to the engine's cooling circuit. The middle hose (2) comes from the cooler and connects to the remote engine oil heat exchanger. The bottom hose (3), with bleeder fitting, connects the engine oil cooler coolant pump to the auxiliary radiator in the wheel well.

The fittings for the hoses (2) and (3) are the same, and the hoses could be mistakenly switched. This would cause an additional coolant to be pumped directly into the engine's cooling circuit, preventing the engine from reaching the operating temperature. If the hoses need to be switched, the cooling system has to be vented and bled properly (Repair Instruction RA17 00 039, "Venting and filling cooling system with vacuum filling unit").

Refer to [SI B12 33 14](#) in case the hoses are installed in correct positions, and the vehicle has the same symptoms.
