This Service Information bulletin supersedes SI B51 39 11 **dated November 2012.**

### Trunk Lid Intermittently Does Not Open or Latch

**NEW** E90 (Sedan)

**NEW** Produced from February 28, 2011 to June 30, 2012

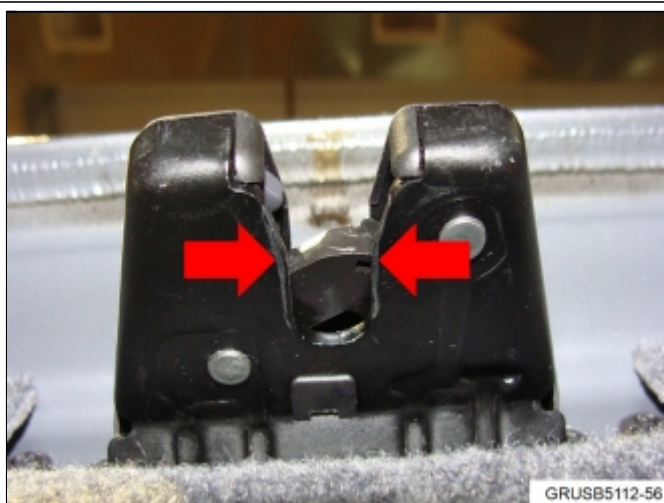
The trunk lid is out of tolerance. When opening or closing the trunk lid, the latch rubs against the striker because of insufficient clearance.

1. Inspect the trunk latch for scratch marks that indicate that the latch is engaging the striker improperly.
2. Replace the latch if scratch marks are found as per ISTA Repair Instructions "51 24 100 Removing and installing/replacing rear lid lock (upper section)."
