Blower Makes an Unusual Noise

F30 (3 Series Sedan)

Produced from May 31, 2011 to February 13, 2013

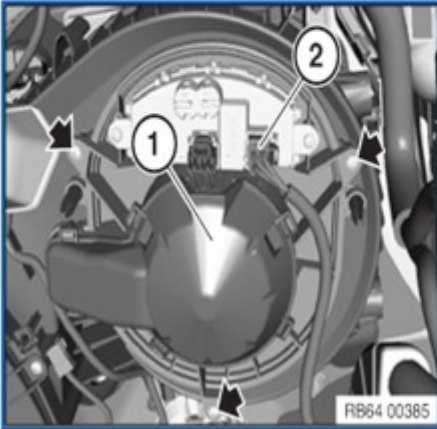
64 11 213 Removing and installing/replacing heating and air conditioning blower

Unlock plug connections (2) and disconnect.

Release screws at marked points.

Remove blower (1).

Hold blower (1) in installation position and tighten all screws evenly.
