iDrive Controller Trim Peeling

E82 (1 Series Coupe)

E90 (3 Series Sedan)

With option 609 (CIC, Car Infotainment Computer)

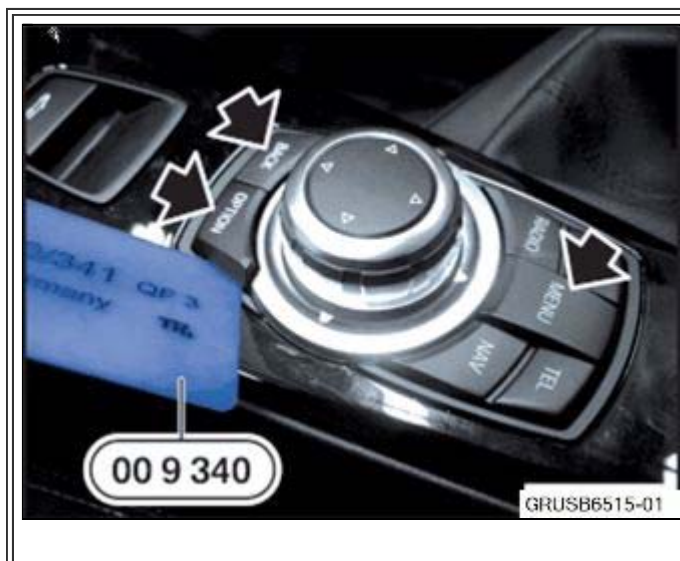
The chrome ring on the iDrive controller is peeling.

Poor chrome material adhesion

1. Carefully pry up the "OPTION," "BACK," and "MENU" buttons with special tool 00 9 340.
