This Service Information bulletin supersedes SI M51 04 14 **dated November 2014**.

### Driver's Side Exterior Door Handle Cover Cap Is Loose

**NEW** F56 (Cooper, Cooper S 2-door Hardtop)

**NEW** F55 (Cooper, Cooper S 4-door Hardtop)

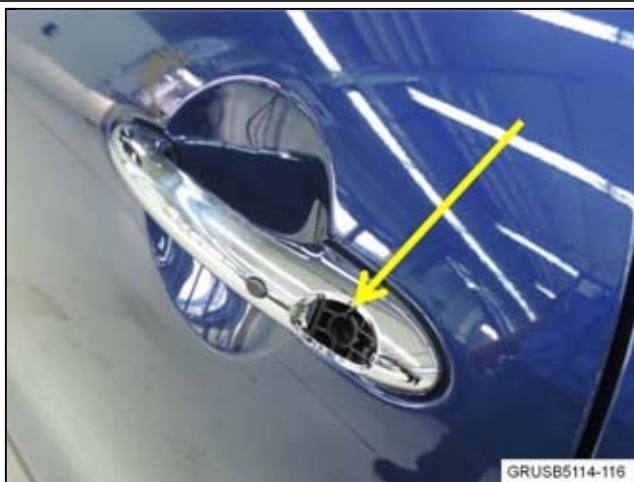
1. The driver's side exterior door handle cover cap is loose or missing.
