### Noise from Steering Column Switch Center when Turning

F55 (Cooper, Cooper S Hardtop 4-door)

F56 (Cooper, Cooper S Hardtop 2-door)

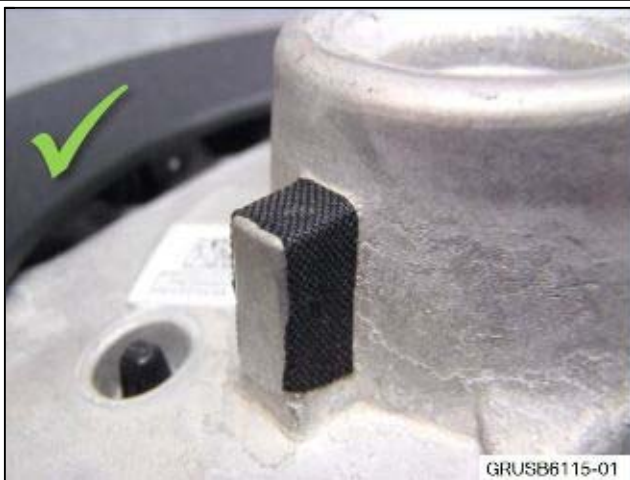
The customer states that there is a grating or scraping noise when the steering wheel is turned. The noise comes from the area of the Steering Column Switch Center (SZL).

When turning the steering wheel, the connection between the steering wheel and the SZL causes torsion stress, creating interference noise.

2. Check the drive flange on the coil spring cassette for adhesive tape, as shown.
3. Install a piece of adhesive tape if it is missing. Cut a piece of adhesive tape from the felt tape set (P/N 51 45 2 353 024) to cover the area shown in the illustration.
4. Remove the four mounting screws and loosen (do not remove) the SZL.
5. Press the SZL all the way against the holder. Reinstall the four screws hand-tight.
6. Tighten the four screws, in the sequence shown, to 3.6 Nm.
