**SUBJECT****N63 Engine: Valve Seal Replacement****MODEL**

F01 (7 Series Sedan)

**SITUATION**

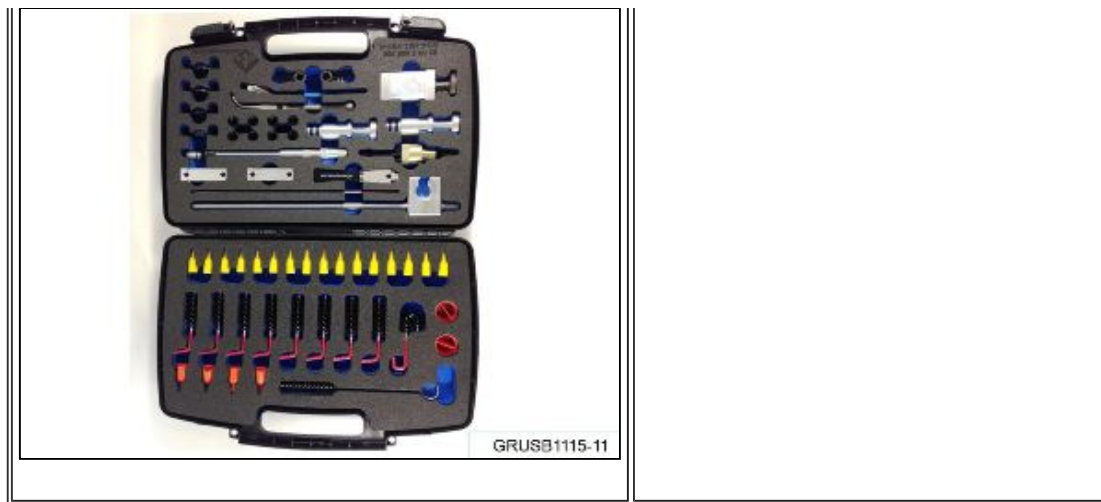
<p>N63 Valve Seal Replacement Tool Kit P/N 83 30 2 408 268 Refer to <a href="#">SI B04 15 15</a> for additional ordering information. Attached to this bulletin is a replacement parts order form.</p>
--	--

If one of these conditions is verified, replace the intake and exhaust valve stem seals using special tool P/N 83 30 2 408 268.
