This Service Information bulletin supersedes SI B13 05 15 **dated April 2015.**

Service Action: Replace Oxygen Sensor

E70 (X5 xDrive 35d)

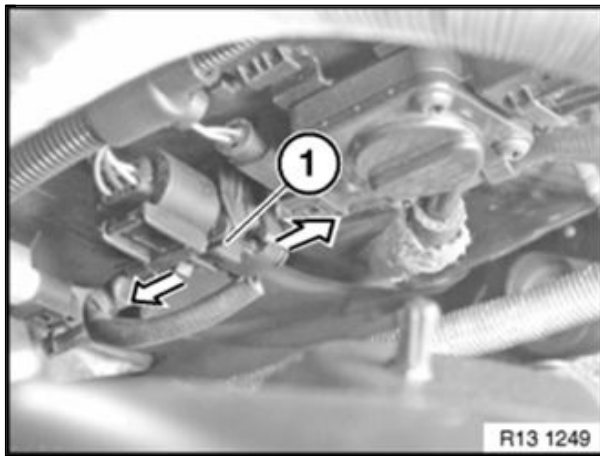
The oxygen sensor deteriorates prematurely.

Unlock the plug connection and pull out of the guide.
Unlock the plug (1) and remove.
