SI B51 07 15  
Body Equipment

### Groaning Noise from Front Door Window Glass

F23 (2 Series Convertible)

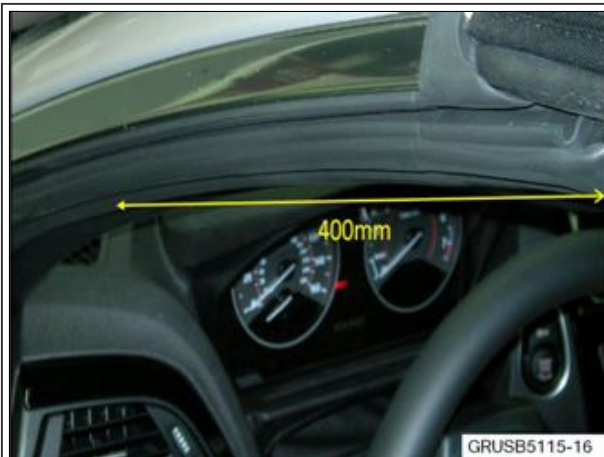
1. The driver's door is shown in the open position. Note: The area of concern is the first 400 mm from the top of the seal near the cowl. This noise can be generated by either the left or the right front window. It is recommended to lubricate both front seals to prevent the customer from returning to the workshop.

Open the door and clean the seal.
