This Service Information bulletin supersedes SI B64 06 13 **dated August 2014.**

**A/C Cooling: Intermittent Reduction of Air Flow**

F30 (3 Series Sedan)

Produced from July 4, 2012 to September 2, 2013

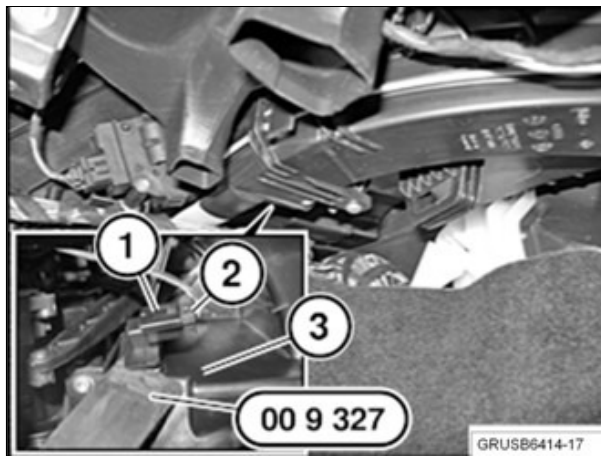
| | <ol style="list-style-type: none"> <li>3. Disconnect the plug connection (2). Unclip the evaporator temperature sensor (1) with special tool 00 9 327 from the heating and air conditioning unit (3), and remove.</li> </ol> |

Ensure the evaporator temperature sensor (2) is correctly seated.

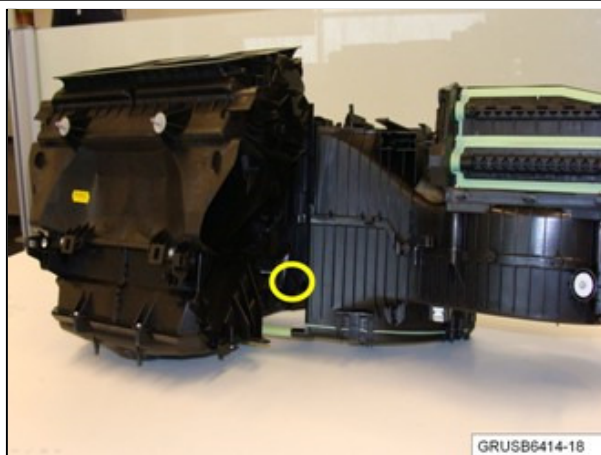
- The IHKA housing (removed for clarity) shown is viewed from the passenger's side. The circle shows the approximate location of the evaporator temperature sensor.

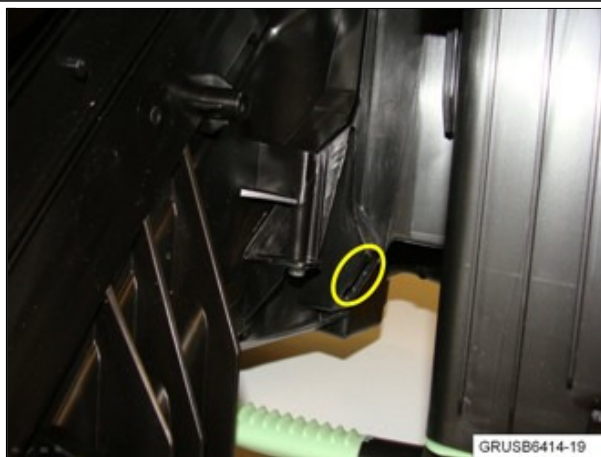
- The close-up picture shows the exact location (circle) of the sensor opening. The following steps will be performed from the lower passenger's footwell area at the bottom of the IHKA housing.

**Note:** As a reference point, the evaporator temperature sensor is located just above the white ribbed rubber water drain hose, when viewed from below.

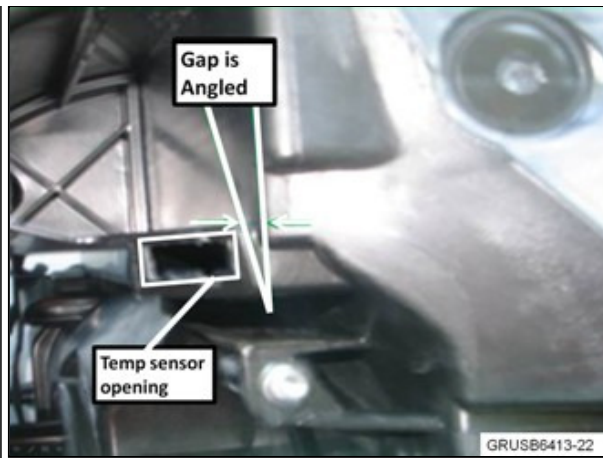
- Locate the evaporator temperature sensor opening (sensor removed for clarity). Check the gap between the sensor opening and the evaporator case. If the sensor opening contact surface is slightly angled as shown, this

housing is **NOT** affected by this repair procedure. In this case, proceed with normal A/C diagnostic procedures.

If no gap exists proceed to the next step.

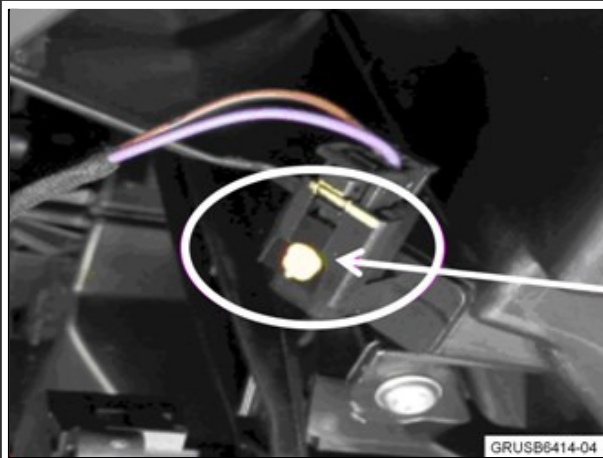
7. Check for a marking on the electrical connector. If a mark is seen or **NO** gap exists, the IHKA housing must be modified.

**Do not replace any parts. The repair procedure includes installing a new adapter to correct the gap.**

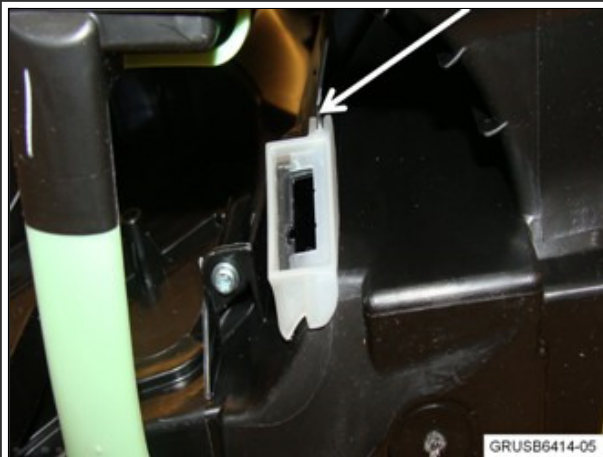
**Note:** The arrow shows the slot in the adapter that is properly fitted into the raised rib of the housing.

8. Insert the new adapter firmly into the sensor opening, as shown.
