SI M51 02 15  
Body Equipment

**NEW** Service Action: Remove Engine Oil Label

F55 (Cooper 4-Door Hardtop, Cooper S 4-Door Hardtop)

F56 (Cooper 2-Door Hardtop, Cooper S 2-Door Hardtop, JCW Hardtop 2-Door)

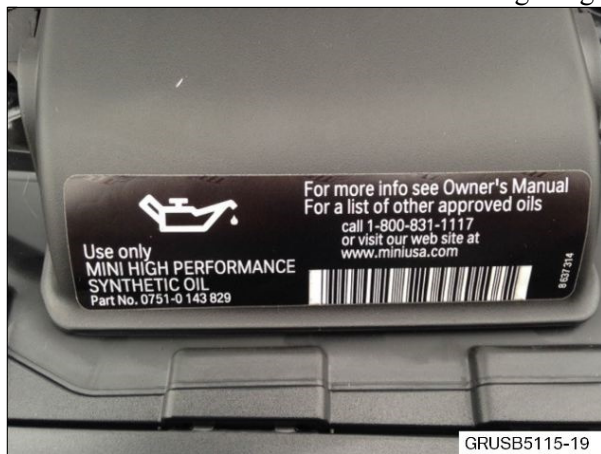
On affected vehicles, there is an incorrect label regarding the appropriate engine oil.

The text on the label does not conform to legal regulations.

Remove the label.

Remove the label using a hot air gun to soften the adhesive. Gently pull the label off while varying the heat. Remove any remaining adhesive with a solvent-based cleaner.

Discard the removed label.
