| Date: May, 2015<br>Bulletin #: 00 003 15 (010) | | Source: BMW Motorrad USA<br>Name: Gery Torok<br>Title: PuMA Technical Specialist | | | | |

# BMW Motorrad USA

## Service Information Bulletin

**Subject:** ICOM Firmware update via ISTA

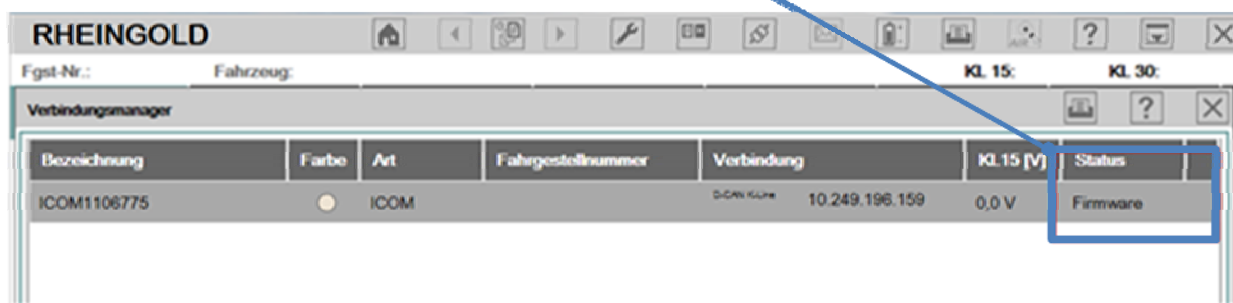
If an ICOM has an old firmware version, the ICOM will have the status "Firmware" in the ISTA connection manager.

You can no longer work with this ICOM until a software update on the current firmware has been performed.  
The following steps are necessary to perform the firmware update
