Noise When Adjusting the Steering Column Up or Down

F15 (X5)

F16 (X6)

F85 (X5 M)

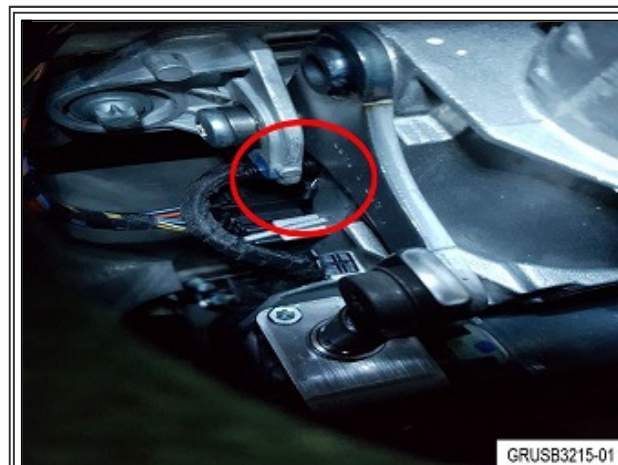
Creaking noise when raising or lowering the steering column position

Steering column adjustment

3. Apply BMW universal anti-friction spray P/N 83 23 2 327 735 to the contact face of the cross section support on the left side of the steering column.

Remove any excess grease.
