SI B33 01 15  
Rear Axle

**Cracking in Rear Differential Mount Bushing**

F10 (5 Series)

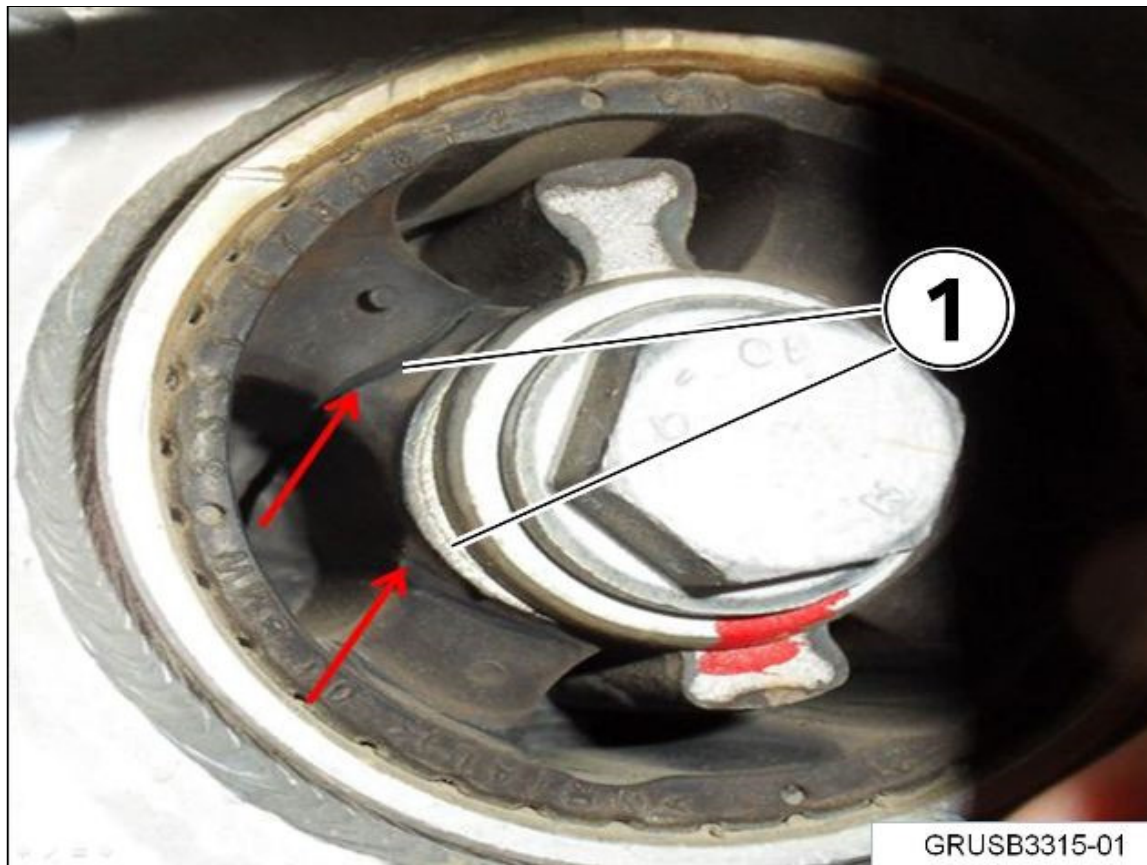
During inspection, the rear differential mount in the rear axle support shows signs of cracking.

- A. Slight surface cracking of the rubber part of the bushing is normal. This type of cracking (1) is not critical to the suspension acoustics or the operational stability of the vehicle. In this case, the differential bushing should not be replaced. However:
- B. If the bushing is cracked “all the way through,” it will need to be replaced.

When applicable (condition “B”), please refer to Repair instruction RA 33 17 005, “Replacing rubber mounts for rear differential mounting at rear.”
