SI B34 08 14
Brakes

July 2015
Technical Service

SUBJECT

Ticking Noise from Front Axle When Cornering

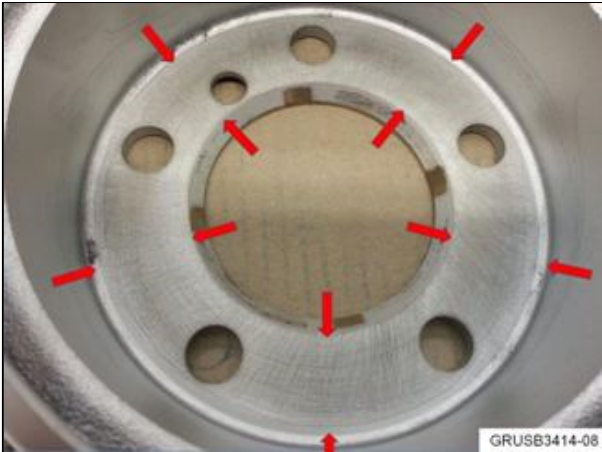
Movement between the brake disc and wheel bearing hub.

<p>Sand the hub surface on the brake disc to the wheel bearing hub using 80-grit sandpaper.</p> <p>Sand the surface in a radial motion (inside to outside around the surface).</p> <p>Clean the wheel bearing hub surface.</p> <p>Important!!</p> <p>Do not sand the hub surface.</p>
--	---

<p>Do not apply any type of lubricant to the components surface (wheel bearing or brake disc).</p>
---	--
