**SUBJECT****Service Action: Replace Both Front Seat Headrests****MODEL**

F33 (4 Series Convertible)

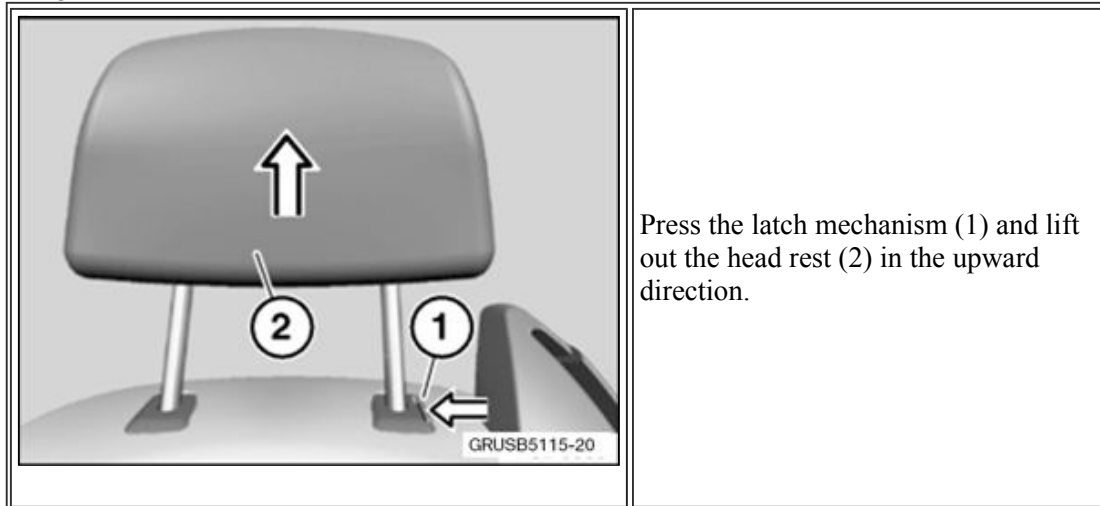
The customer may hear rattling noises coming from the front headrest while driving.

A spring inside the front headrest may come loose, causing a rattle.

Replace both front headrests using Repair Instruction 52 14 390, "Removing and installing/replacing front left or right head restraint."
