**Cannot Update Bluetooth Software (KISU Data)**

E89 (Z4)

With COMBOX option 6VB (CMedia)

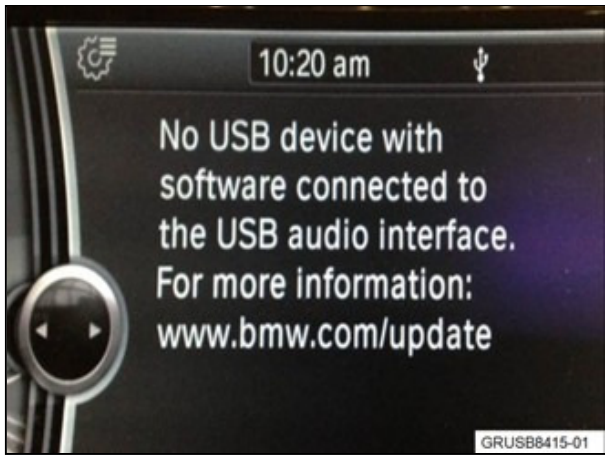
<ul style="list-style-type: none"> <li>This is the message seen in the CID display when performing the KISU software update.</li> </ul> <p>Note: It is not necessary to visit the website as stated in the message.</p>
--	---

Incorrect coding software installed in the Combox

Perform a complete vehicle encoding using ISTA/P 3.55.3 or higher.

- Connect the vehicle to ISTA/P.
- Perform a complete vehicle encoding.
- Perform the KISU software update in the vehicle.
