US 61737304-01

Protective film on the rear frame

Vehicles affected**E series**

K54

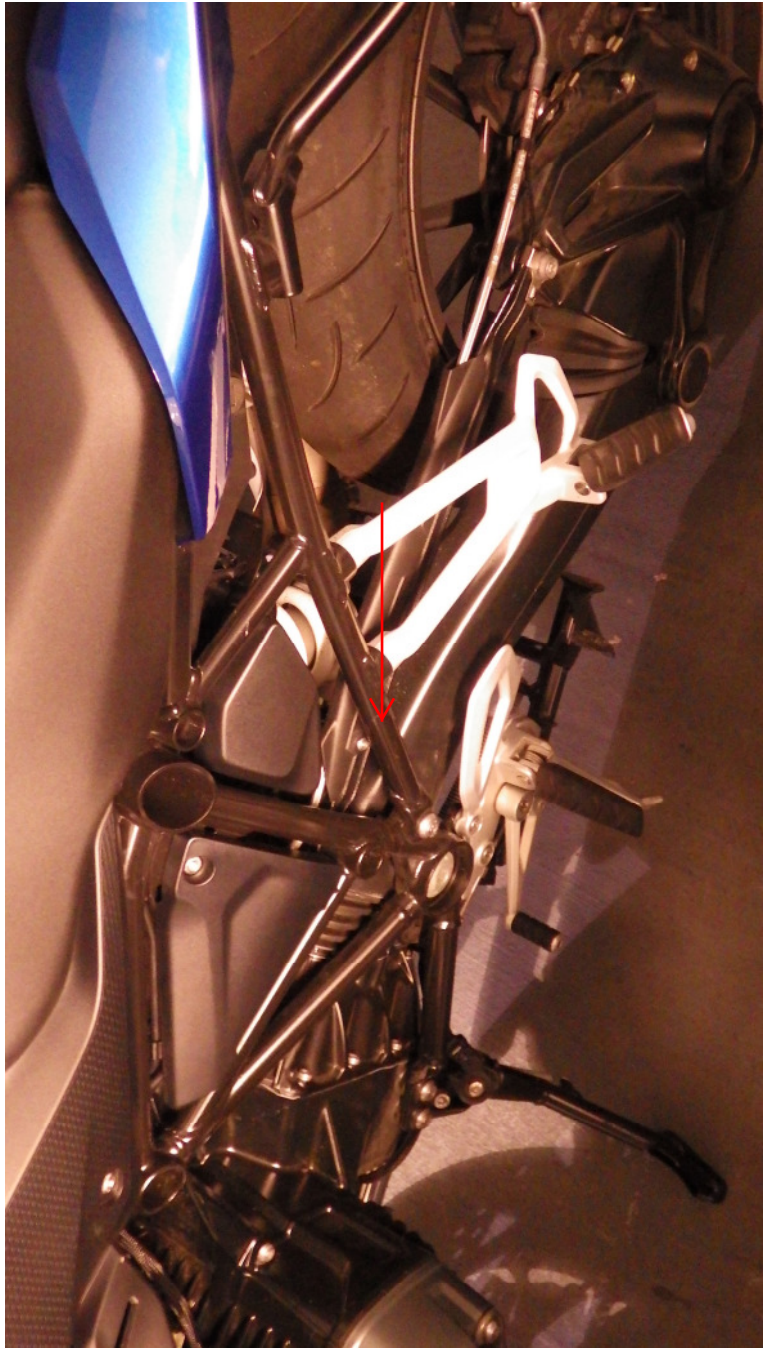
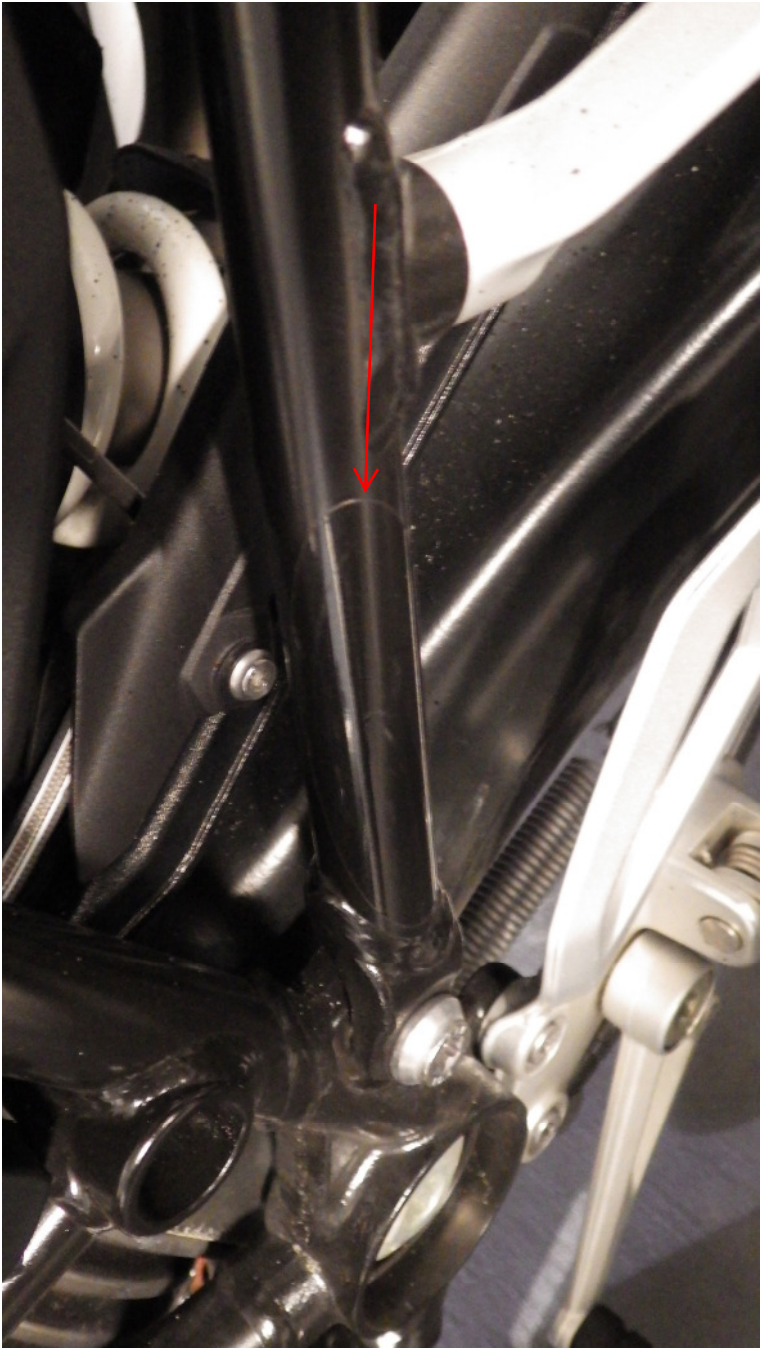
This protective film is applied only to the black frame on the left when viewed in the direction of travel.

The attachment contains an image of the protective film.

46 51 8 524 784 Rear frame, black >> 1 x 46 51 8 561 402 protective film

46 51 8 555 831 Rear frame, agate grey >> No protective film

Vehicles with the black rear frame should have the protective film on the left side when delivered.

Vehicles with the agate grey rear frame will not have the protective film and do not need it.

No action is required.
