This Service Information bulletin supersedes SI B12 18 14 **dated March 2015**.

### Engine Misfire Due to Failed Ignition Coil

With the N51, **NEW** N52\*, N52K, and N52T engines

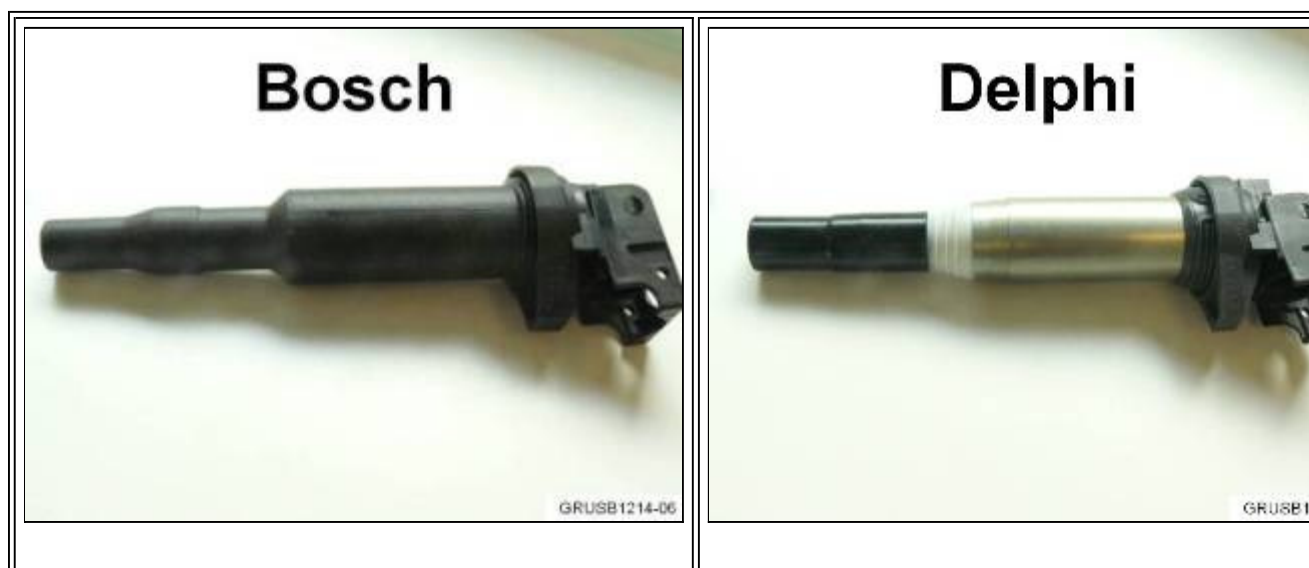
### Ignition Coil Identification

During operation with high temperature fluctuations, the different materials used in the Bosch ignition coil construction can deteriorate over time, leading to a failure.

1. **NEW** For vehicles with the **N51, N52 (from 4/2006), and N52K** engines which have been in service for over 24 months or 10,000 miles: during the first service visit due to an ignition coil failure, replace **all Bosch** ignition coils with **Delphi** coils as indicated in ETK (March 2015).

If any ignition coil(s) was replaced previously with a **Delphi** part, it does **NOT** need to be replaced.

2. For the F10 and F25 with the **N52T** engine, replace **all Bosch** ignition coils with the replacement **Delphi** coils under these situations:
  - At the first service visit with for an ignition coil failure
  - Alternator failure (see [SI B12 12 13](#))
  - DME replacement due to a failed Bit Serial Data (BSD) interface circuit
