SUBJECT
Water Leak in the Right Rear Luggage Compartment Area
MODEL

E84 (X1)

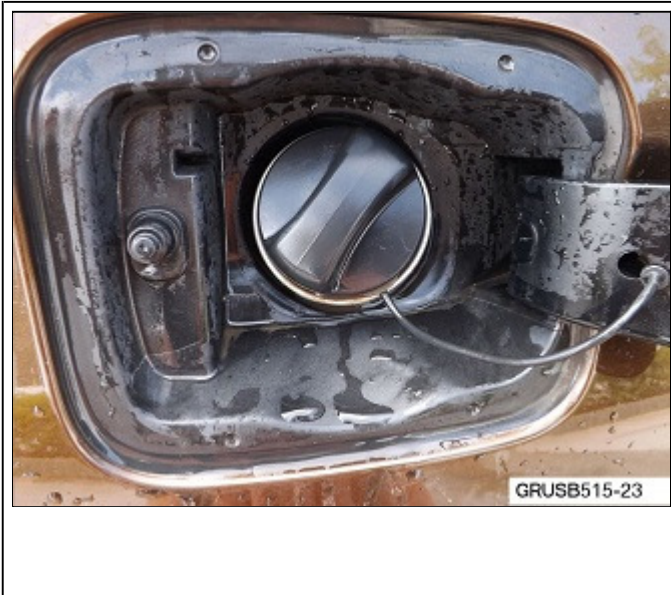
Water leaks into the right rear luggage compartment area and can damage any control modules located there (for example Park Distance Control PDC). Various Check Control Messages may also be displayed.

Water leaks through the seal in fuel filler cover bowl area.

<p>Perform a water leak test the area of the fuel filler flap and cover bowl. If traces of water are found the right rear trunk area, replace the cover bowl.</p> <p>Refer to ISTA repair instructions “ 41 63 003 Replace cover bowl” Note: When replacing the cover bowl make sure, that the sealing surface of the body is clean and dry. Put a thin layer of a silicone sealer between the body and cover bowl seal before assembly</p>
--	--
