SUBJECT

Driver or Passenger's Front Doors Handles Inoperable

F30 (3 Series Sedan)

Produced up to February 19, 2015

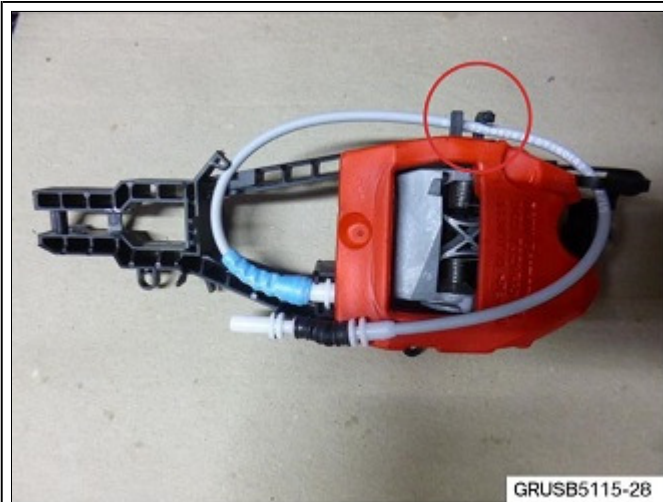
Incorrect routing of the Bowden cable.

This picture shows that the Bowden cable is clipped in place on the support, which is putting unnecessary stress on the cable.

Unclip the cable from the support and retest, to make sure that the door opens freely each time.
