September 2015 Technical Service

**Service Action: Replace Automatic Recirculation Sensor**

F25 (X3)

F26 (X4)

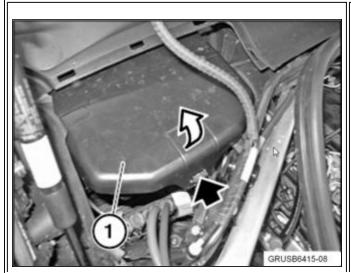
- Remove the cover and seal in order to access the micro filter. REP 64 31 105 "Removing and installing / replacing right micro filter housing cover".
- Remove filter cover (1) in direction of arrow as shown.

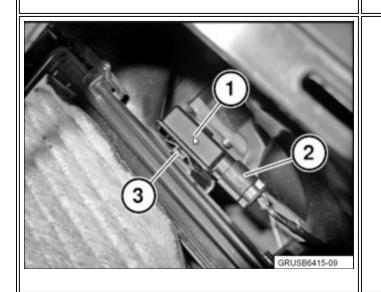
- Unfasten plug connection (2) and disconnect.
- Unlock retaining tab (1) and remove AUC sensor.

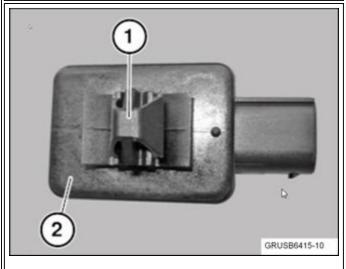
# Installation note:

- Retaining tab (1) on AUC sensor (2) must not be damaged.
- The AUC sensor must be pointing downwards.
