SI M64 01 15
Heating and Air-conditioning

Air Draft into Driver's Foot-well

F56 (Cooper, Cooper S 2 door hardtop)

Produced from November 30, 2013 to January 28, 2014

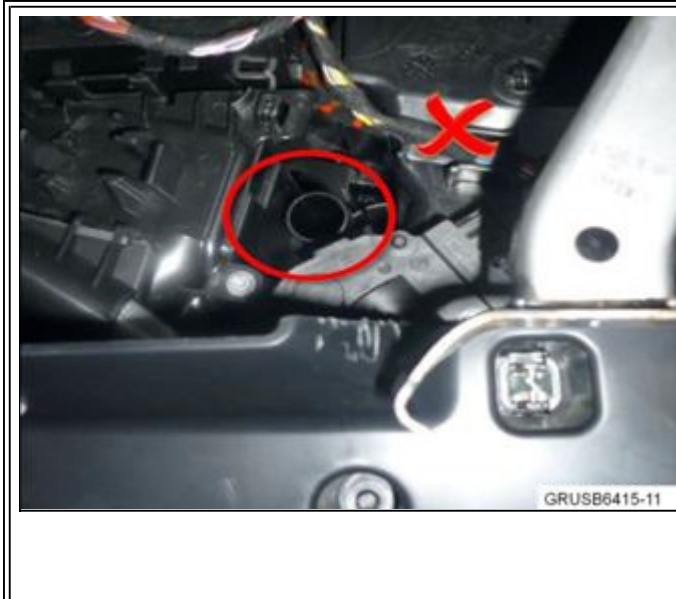
As shown in the picture, the plug is missing from the air conditioning housing near the driver's foot-well area.

The missing plug may be found in the vehicle **DO NOT** reinstall since it fits too loose and may fall out again.

Replace with a new plug.

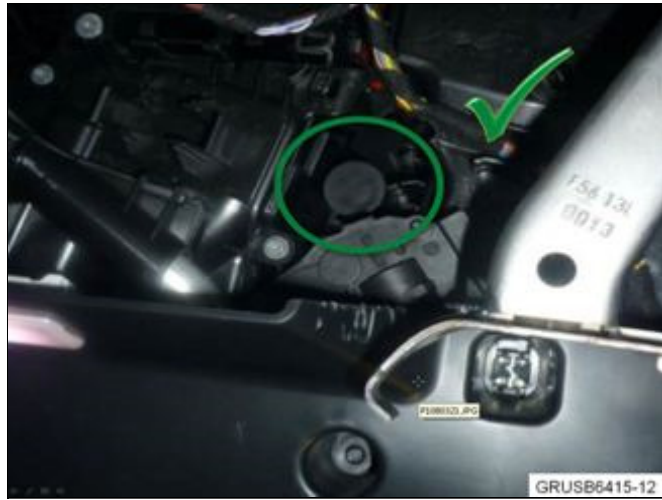
1. In the driver's foot-well area, locate the area where the plug should be installed.
2. The close up picture shows the exact location of the plug.

3. Install a new plug.

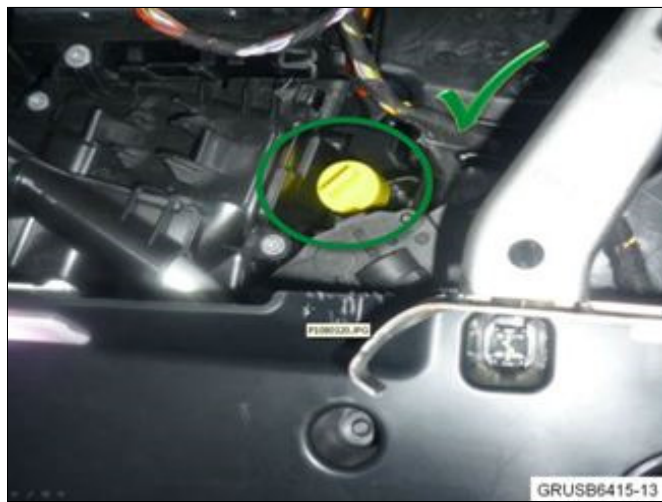
- The new plug is shown installed.
