Ticking Noise from Front Axle When Cornering

F22 (2 Series Coupe)

F30 (3 Series Sedan)

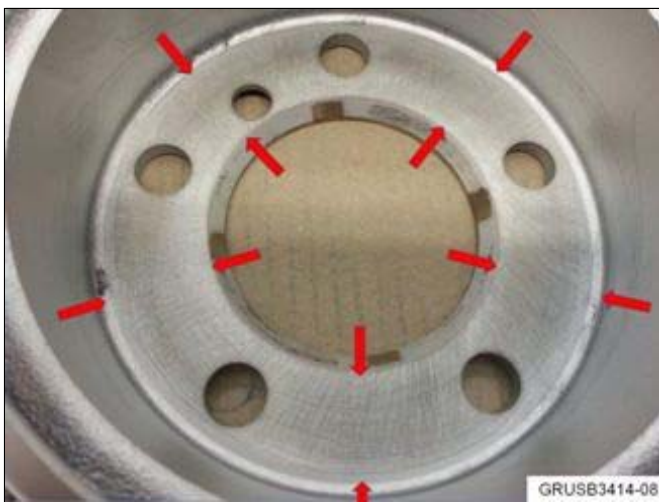
The customer may complain of a ticking noise from the front axle when cornering, maneuvering, parking or pulling away from a parking space. The noise can be heard as a light metallic ticking from the front outer cornering wheel.

Movement between the brake disc and wheel bearing hub.

Remove and clean the front axle brake discs.

Sand the hub surface on the **brake disc** to the wheel bearing hub using 80-grit sandpaper.

Sand the surface in a radial motion (inside to outside around the surface). Clean the wheel bearing hub surface.

Do not sand the hub surface.

Do not apply any type of lubricant to the components surface (wheel bearing or brake disc).

Reinstall the front axle brake discs.
