**Service Action: Replace Neck Warmer Control Unit**

F33 (4 Series Convertible)

F83 (M4 Convertible)

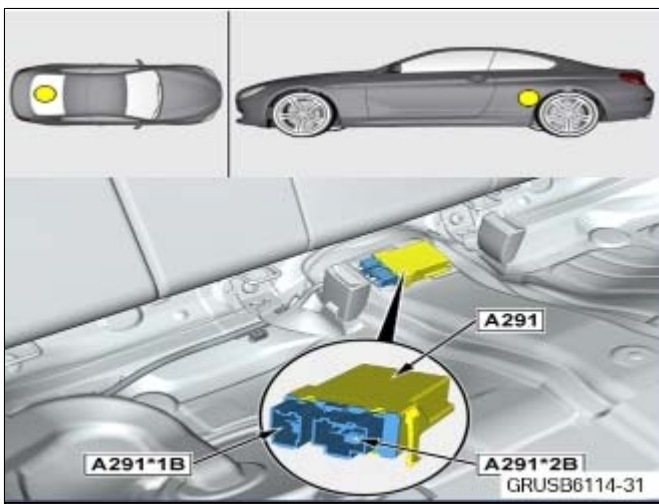
| | <ol style="list-style-type: none"> <li>1. The control unit is located under the rear seat bottom, as shown in the photo, and is clipped in place.</li> <li>2. Unplug the two electrical connectors and remove the neck</li> </ol> |

warmer control unit.
