## BMW Motorrad USA

### Service Information Bulletin

**Subject:** Wire Harness Routing

**Models:** 2009 - 2013 BMW R 1200 RT-P (Police)

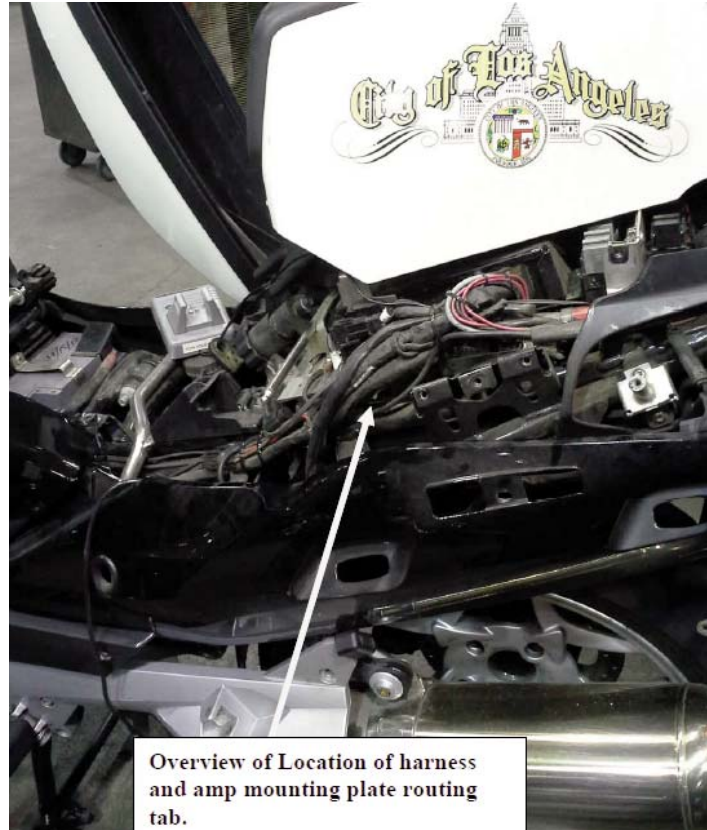
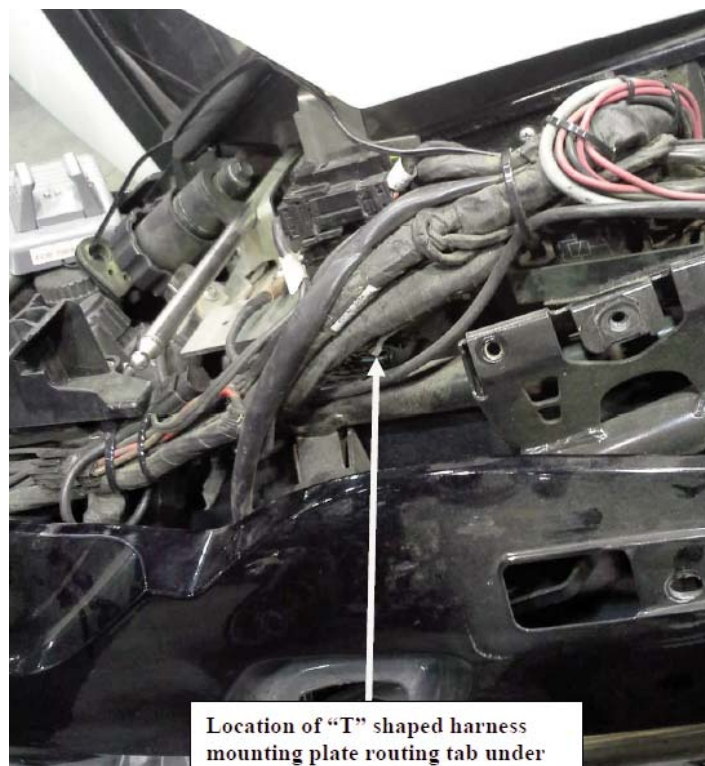
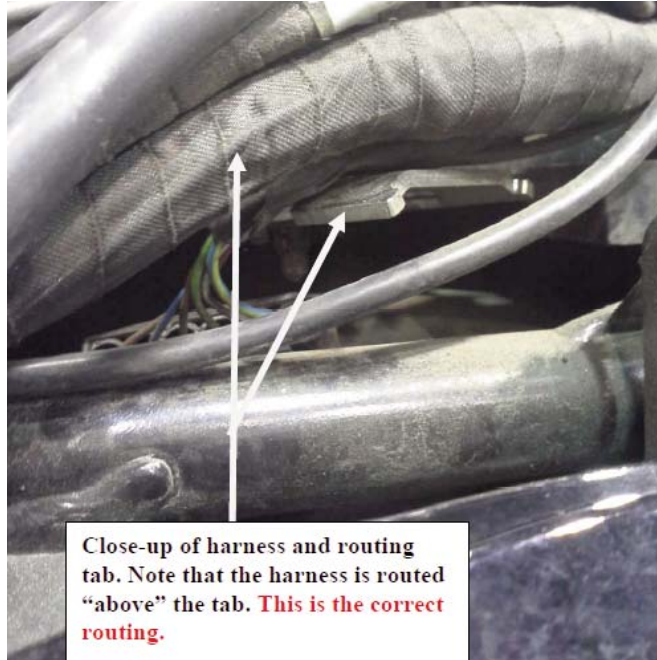
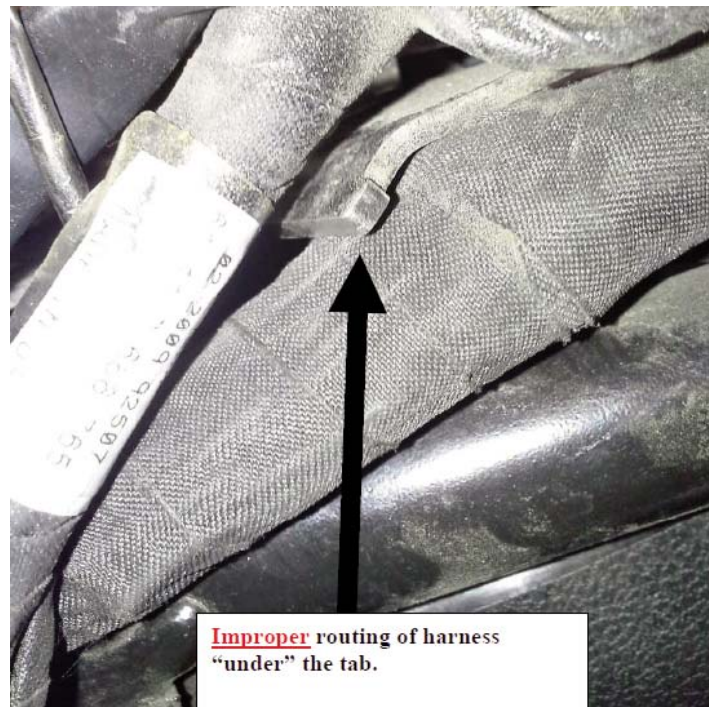
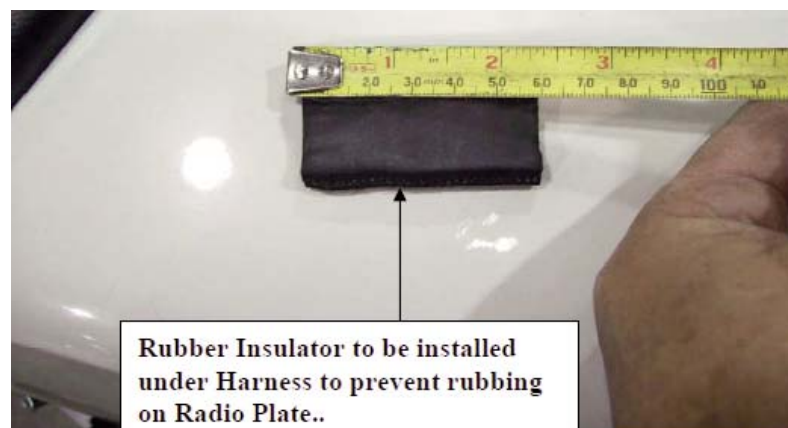
**Details:** Installers may alter the original positioning of the wiring harness cables when routing radio or accessory cable during the up-fitting, or during repairs to the R 1200 RT-P model (example: clutch replacement) resulting in the following symptom: The emergency lights on the top box mounted to the rear of the motorcycle may stay on with the emergency light switch in the off position. Investigation has discovered the cause to be a short in the main wiring harness at the rear of the motorcycle. The location is under the radio box floor plate, by the siren amp mounting plate. The short is caused by the auxiliary battery's main positive cable and the rear emergency light wiring rubbing and chafing on the "T" corners of the siren amplifier mounting plate harness securing tab.

Work Item: Gain access to the main wiring harness under the top box on the left side of the siren amplifier mounting plate. Install the rubber insulation between the siren amplifier mounting plate wiring routing tab and the main harness positive auxiliary battery cable and the rear emergency light wiring. The insulator will be approximately two inches in length by one inch in width of rubber tubing. Secure the MTD 13-012 wiring harness and the rubber insulator to the routing tab using plastic wire ties. (See following photos). After completion, a white dot will be placed on the left rear crash bar mounting tab to designate the repairs have been performed. (See attached photos).
