**SUBJECT****N20 and N26 Engine: Oil Leaks from Cylinder Head Cover****MODEL**

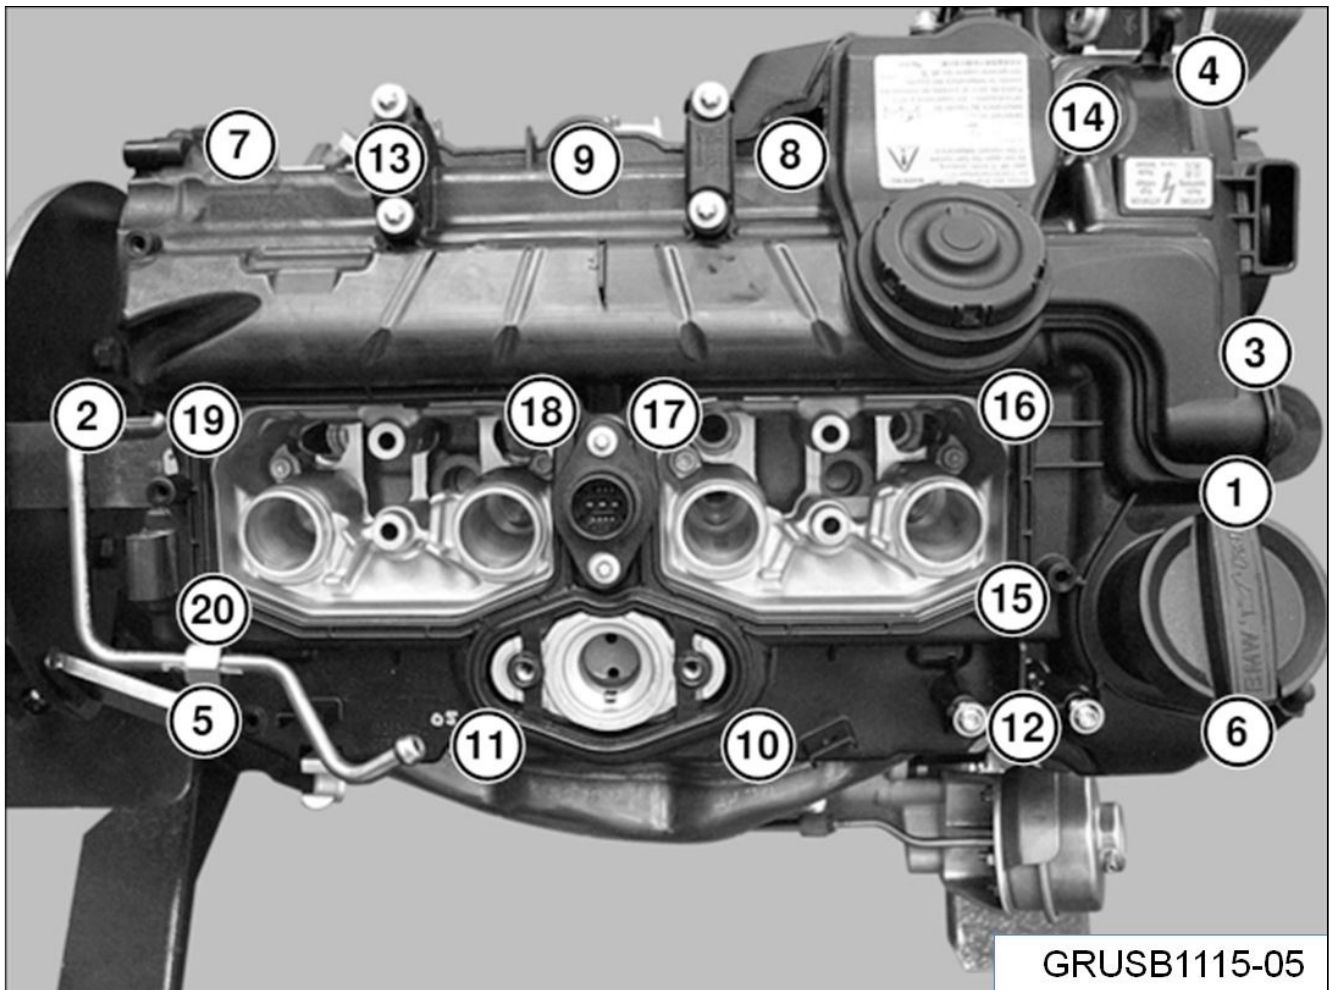
The cylinder head cover gasket is leaking engine oil due to loose retaining bolt(s).

3. If one or more of the bolts require additional tightening to achieve 6 Nm of torque, note the location of the loose bolt(s) using the identifying bolt numbers in the illustration.

2. Check that all of the cylinder head cover bolts are tight, using the tightening sequence in the illustration below. Retighten each bolt to 6 Nm.

5. Replace the cylinder head cover gasket using P/N 11 12 7 588 418. Refer to Repair Instruction 11 12 000, “Removing and installing/sealing cylinder head cover (N20, N26).”
