SI B34 02 15
Brakes

Service Action: Program Control Units (DSC)

F02H (ActiveHybrid 7)

F10H (ActiveHybrid 5)

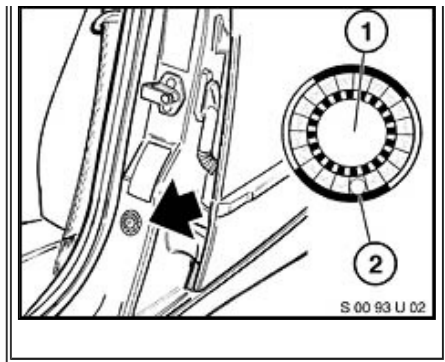
- A. Emboss your BMW center warranty number in the middle of the label (1);
- B. Punch out code number **739** (2), printed on the label; and
- C. Affix the label to the B-pillar as shown.

If the vehicle already has a label from a previous Service Action/Recall Campaign, affix the new label next to the old one. Do not affix one label on top of another one because a number from an underlying label could appear in the punched-out hole of the new label.
