Harman Kardon Surround Sound System Noise

F36 (428i Gran Coupe, 435i Gran Coupe)

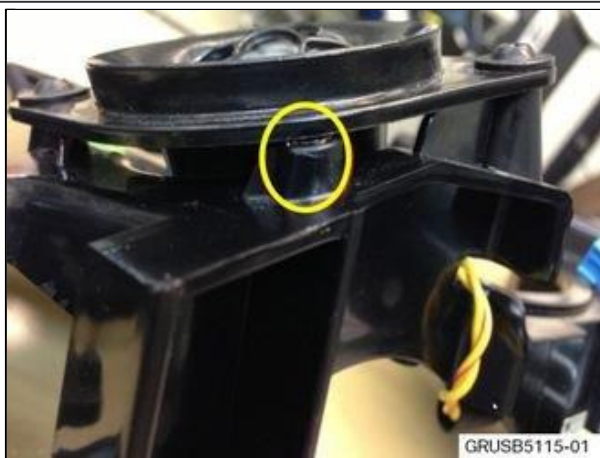
Lack of clearance between the tweeter and the mounting contact and/or wires

1. The tweeter bracket has three raised areas. Only two screws hold the tweeter to the bracket. The yellow circle shows the other raised area where the tweeter is in contact with the bracket. Apply a 5 x 10 mm piece of felt to the area between the tweeter and the bracket. This will eliminate the noise.

Apply a felt strip to the affected contact area.

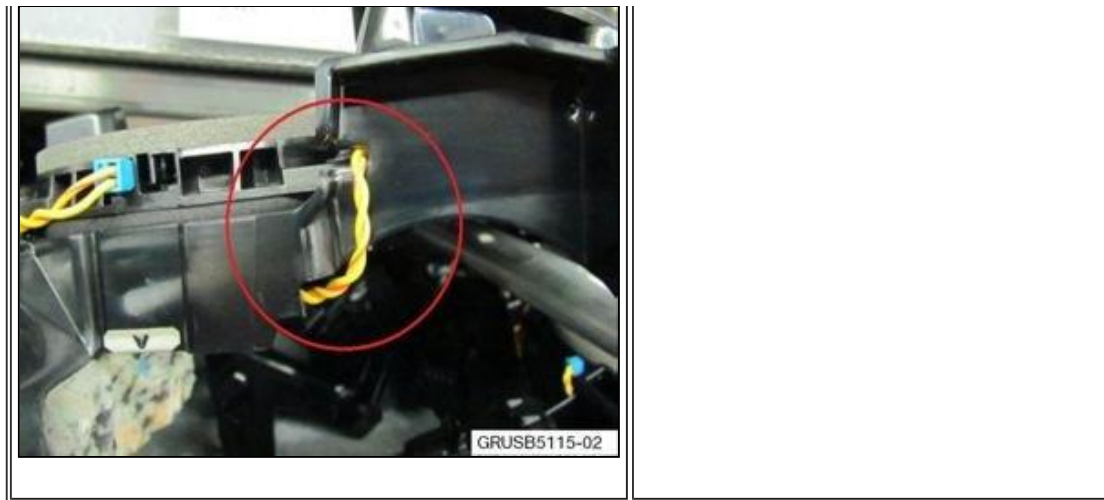
2. Check and rattle the two wires for the tweeter. If these wires are making noise, wrap them with another felt strip.
