SI B51 05 15
Body Equipment

Groaning Noise when Opening and Closing Rear Doors

I01 (i3, i3 REx)

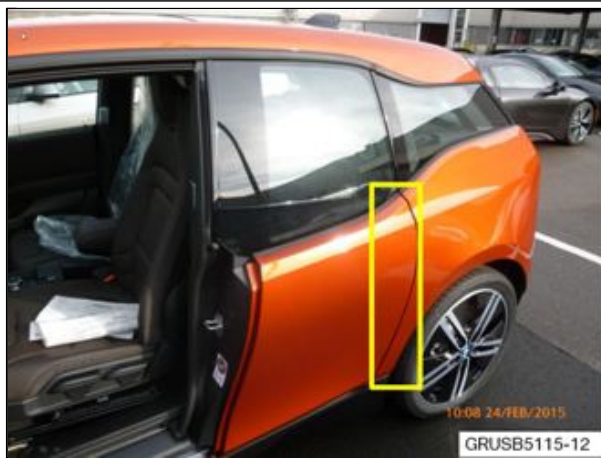
1. Locate the affected rear door and open and close the door several times. Look for signs of contact between the rear door edge and rear side panel.

If the noise can be reproduced, proceed to the next step.
