### Various Check Control Messages Caused by Shorted K-CAN

F22 (2 Series Coupe)

F32 (4 Series Coupe)

F34 (3 Series Gran Turismo)

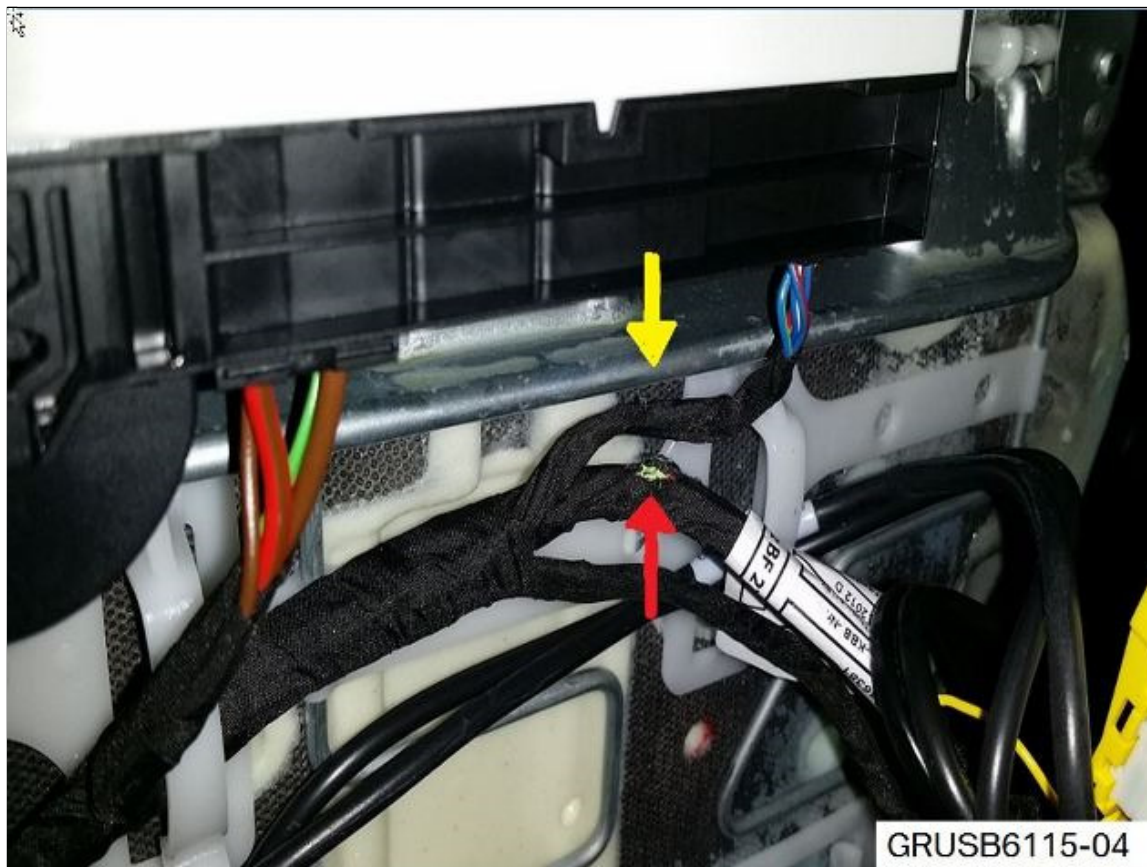
Shorted KCAN wiring under driver or passenger seat

1. Perform a vehicle test with ISTA. Identify if any CAN-related faults are shown, as listed above.
2. First look at the wiring harness under the seat bottom for areas where it rubs against the seat frame, as seen below.

Find the shorted harness. Repair and re-route it to prevent a repeat visit.

3. Repair the wiring harness as needed.
4. Secure the harness away from the seat frame.
