Washer Fluid Reservoir Rattles While Driving on Rough Roads

F23 (2 Series Convertible)

Produced from August 13, 2014 to December 7, 2014

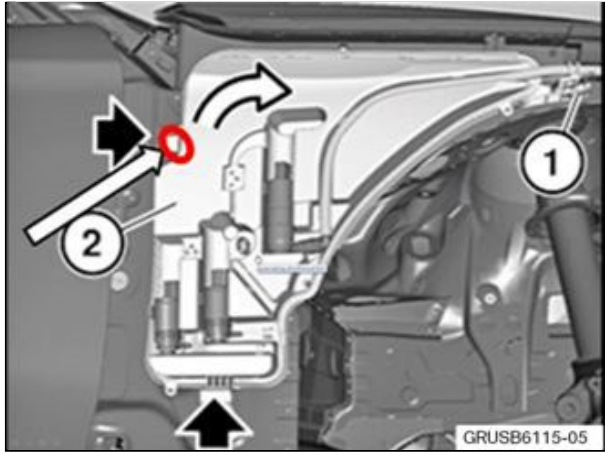
<p>Note: The picture shown is with the passenger side fender removed for clarity purposes. Remove the screw (1). The tightening torque is 8 Nm. Pull the washer fluid reservoir (2) out of the guides (arrow) in the direction of the arrow. Unlock and disconnect all plug connections. Unlock the filler hose and pull it off the fitting on the washer fluid reservoir.</p> <p>Note: Catch any escaping washer fluid if necessary.</p>
	<p>The close-up picture shows a gap (0.40 mm) that exists between the plastic reservoir guide and the metal securing bracket. With the reservoir removed, clean the upper guide tab with a clean cloth. Prepare a piece of felt tape (80 x 60 x 1 mm) and apply it to the guide tab in the area shown. The felt tape will eliminate</p>

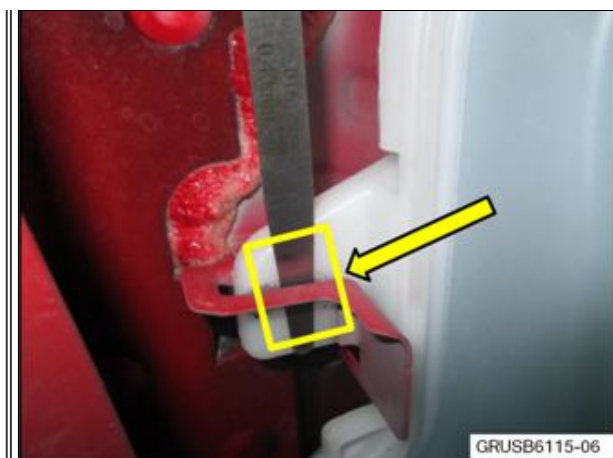
the rattling noises coming from the metal bracket which can transmit into the glove compartment area. Reinstall the removed parts in the reverse order of their removal.
