Check Control Message: Tire Pressure Monitor (RDCi) Failure

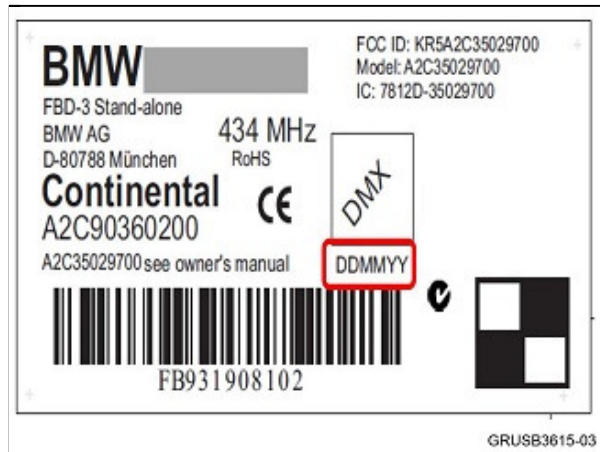
Hardware in the remote control unit (FBD3 antenna)

- Visually inspect the valve stems for damage. Repair as necessary
- If no problem is found during visual inspection, replace the remote control unit (FBD3) in accordance with the model specific repair instructions REP 61 31 362.
