**SUBJECT**
**i8: Retrofitting High-Voltage Battery Ground Cables**
**MODEL**

I12 (i8)

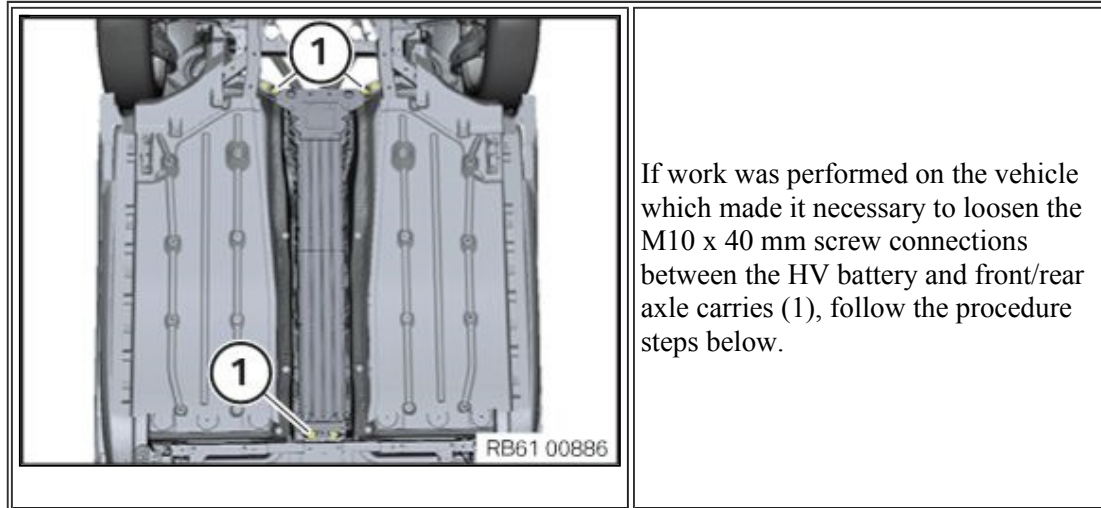
After HV battery (or front axle support) removal and reassembly, HV battery grounding points contact resistance (on both axles) may increase. As a result, the HV battery housing grounding path (resistance value) will be incorrect.

1. Inspect whether the additional ground cables are already fitted between the HV battery housing and the front/rear axle carries. If the cables are not found, retrofit both ground cables using the repair instructions below:

2. If the additional ground cables were already installed, clean the corresponding contact surfaces on the HV battery and front/rear axles, following appropriate precautions:

On all contact surfaces, sand the oxidized coating using a fine sandpaper (P500 or finer) with a planar sanding block.

Do not touch the contact surfaces after they have been sanded, and do not use any cleaning agents. Using cleaning agents (e.g., brake cleaner) may promote the formation of oxide coating.

To prevent oxidation of the surfaces, the M10 x 40mm screw connection for the grounding cables must be established within 10 minutes after sanding.
