SI M23 01 15
Manual Transmission

Manual Transmission Will Not Stay in First Gear

F55 (Cooper, Cooper S 4-door Hardtop)

F56 (Cooper, Cooper S 2-door Hardtop)

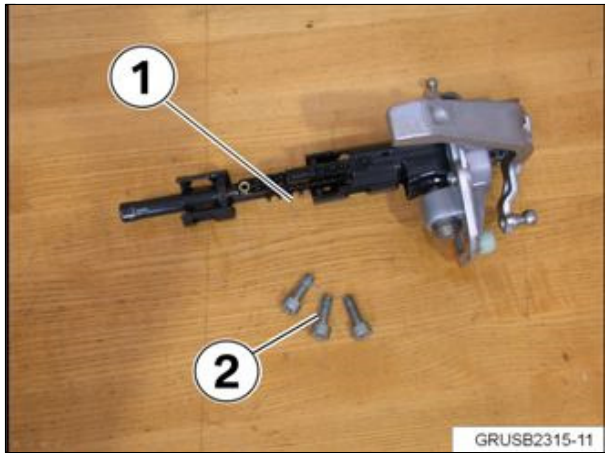
When starting off in first gear, the transmission may “pop” into neutral.

Insufficient spring tension in the shifting mechanism of the manual transmission

<p>The shifter tower for the transmission will need to be replaced. The repair kit (P/N 23 00 8 654 531) consists of the improved shift tower and three screws. A flange gasket sealer (P/N 83 1 90 422 969) will also be needed to complete the repair.</p>
--	--
