SI B11 08 15  
Engine

October 2015  
Technical Service

**N63 Engine: Valve Seal Replacement**

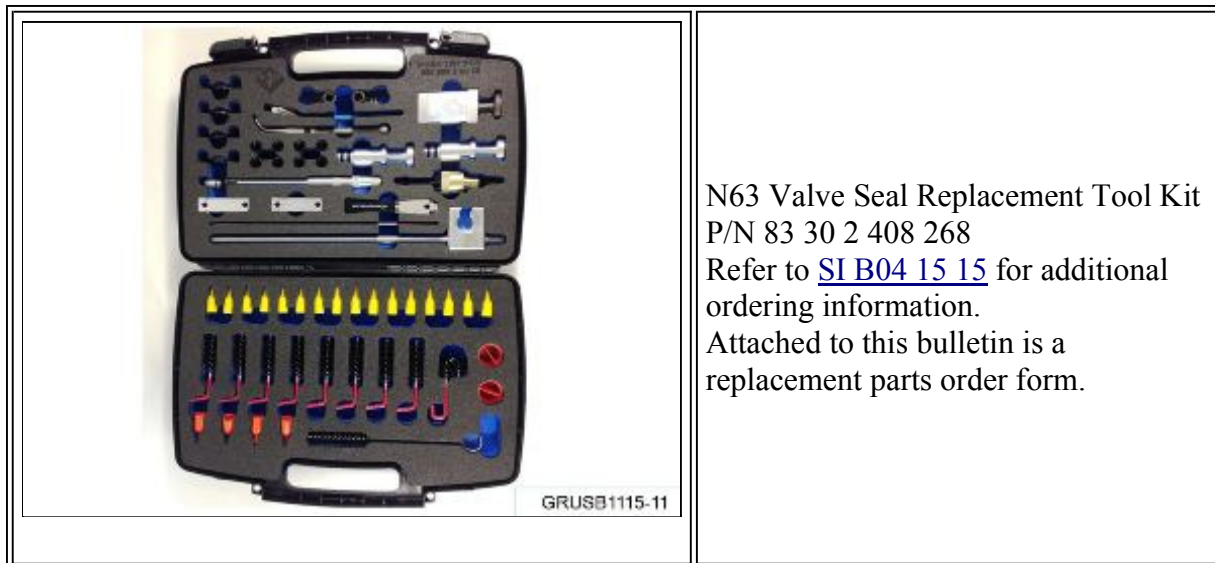
If one of these conditions is verified, replace the intake and exhaust valve stem seals using special tool P/N 83 30 2 408 268.
