SI B11 14 15
Engine

October 2015
Technical Service

Service Action: N55 Engine - Inspect and Replace Engine Oil Filter Housing

F30 (3 Series Sedan)

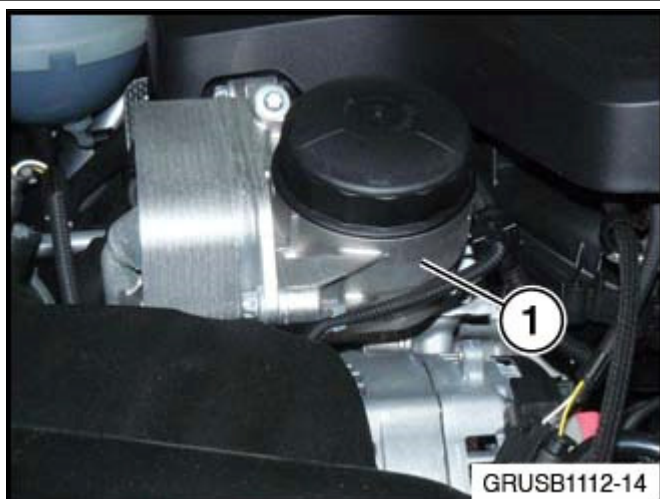
1. Inspect and replace the engine oil filter housing as per the repair instructions.

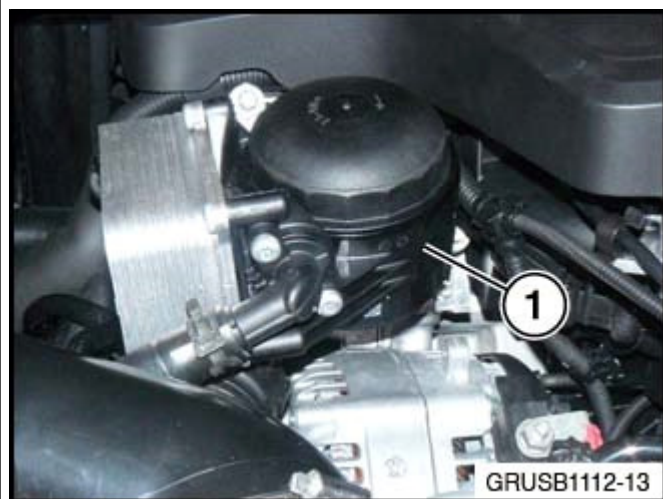
2. If the vehicle is fitted with the aluminum oil filter housing (silver color) then take no further action. Do not replace any parts.

3. If the vehicle is fitted with the plastic engine oil filter housing (black color) then replace the engine oil filter housing as per the attached instructions.
