**SUBJECT****N63 - Drivetrain Malfunction Warning with Quantity Control Valve Faults****MODEL**

F01 (7 Series Sedan, BMW ALPINA B7, BMW ALPINA B7 xDrive)

With the N63 engine

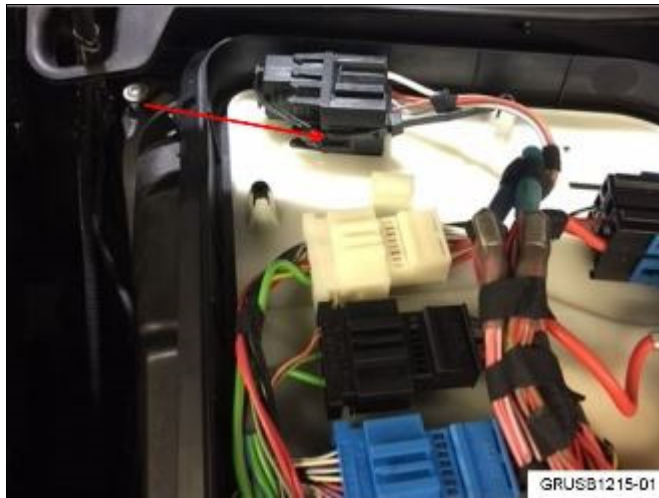
The most likely cause is the high fuel pressure quantity control valve relay (K6342) loose connection at the electrical connector.

1. Perform the recommended test plans using the latest version of ISTA/D.
2. Reseat and secure the relay to the electrical connector plug with a wire tie.
