Squeaking Noises from Rear of Vehicle

I12 (i8)

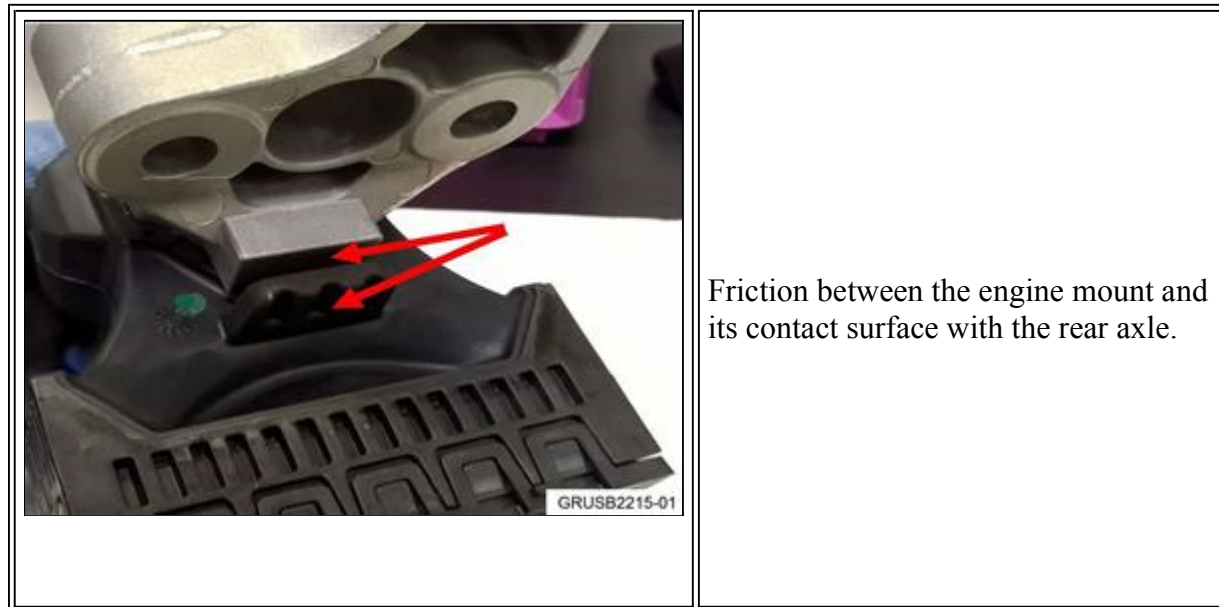
Squeaking noises coming from the rear area may be heard in the vehicle interior when driving over rough or uneven road surfaces

Grease contact point between the engine mount and the rear axle.
